Report of Marine Survey

Prokat

2660 Catamaran CC, 2007

April 20, 2021

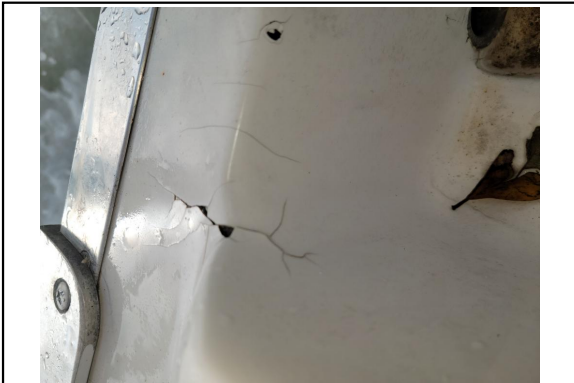
Transom-Spider Cracks

Spider Web Cracks at port transom corner.

FINDINGS	RECOMMENDATIONS
Spider Web Cracks at port transom corner.	Further investigate and repair with like kind materials in keeping with accepted marine repair practices.

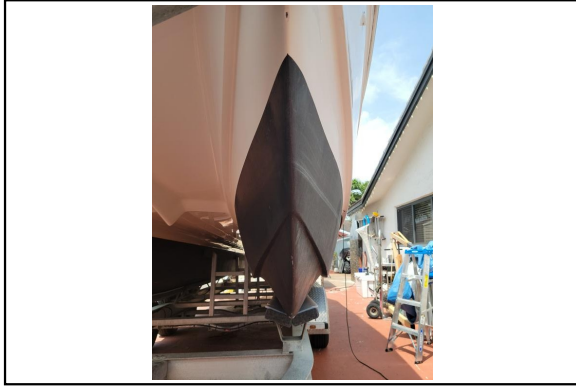
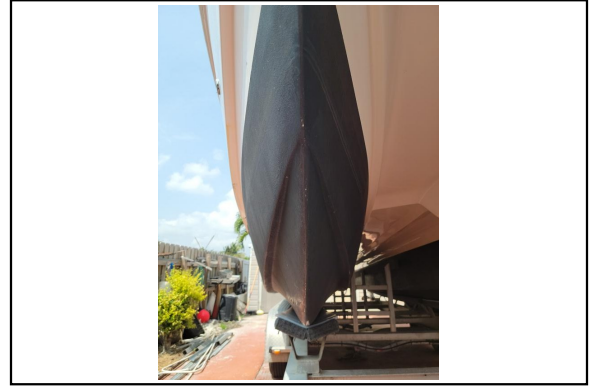
No ground damage noticeable. The hull was checked with a rubber hammer in-order to detect blistering.

The gelcoat on the hull is showing signs of being chucky.

FINDINGS	RECOMMENDATIONS
The gelcoat on the hull is showing signs of being chunky.	Compound and Wax Hull.

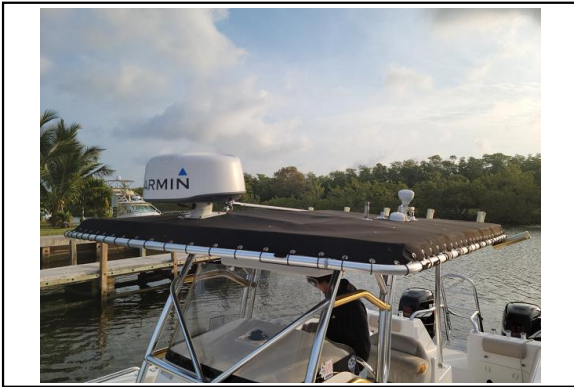
The T-Top canvas is worn it does not hold water.
The canvas is torn were the marine antenna lays over.

FINDINGS	RECOMMENDATIONS
The T-Top canvas is worn it does not hold water. The canvas is torn were the marine antenna lays over.	Repair or Replace with marine grade material and practice.

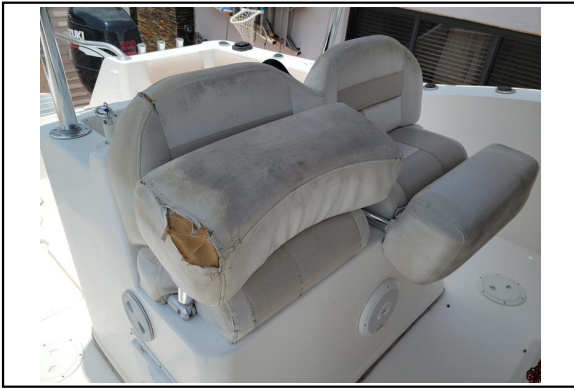
Helm Seat

Upholstery is worn and torn.

FINDINGS	RECOMMENDATIONS
Upholstery is warn and torn.	Further investigate and repair as necessary.

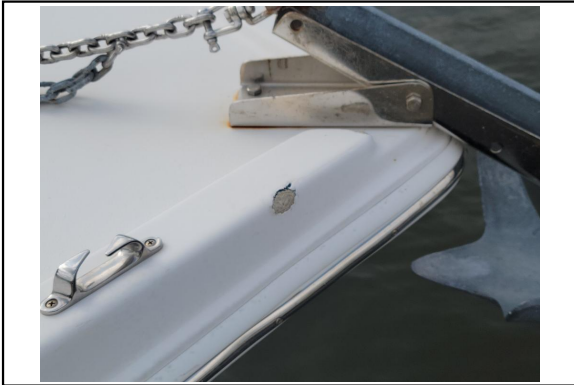
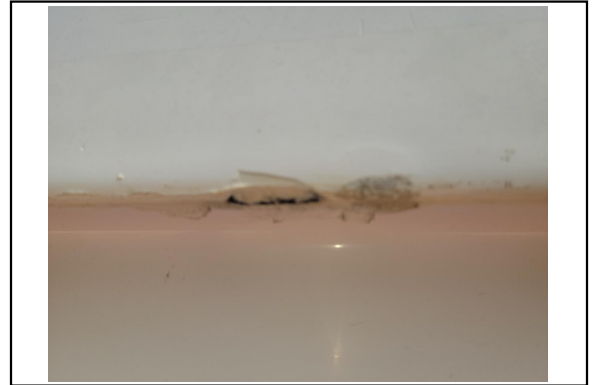
Two gel-coat damages near the anchor and STBD bow side.

FINDINGS	RECOMMENDATIONS
Two gel-coat damages near the anchor and STBD bow side.	Further investigate and repair with like kind materials in keeping with accepted marine repair practices.

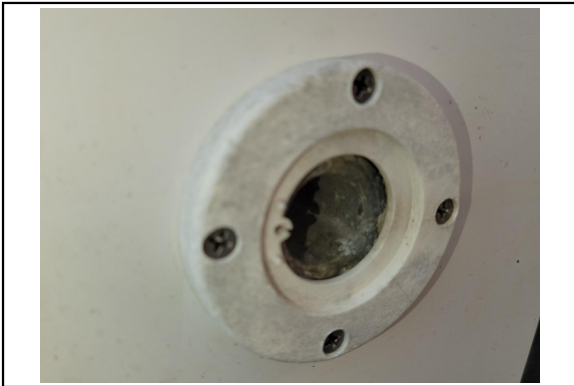
Scuppers

Two (2) scuppers need service.

FINDINGS	RECOMMENDATIONS
Two (2) scuppers need service.	Further investigate and repair as necessary.

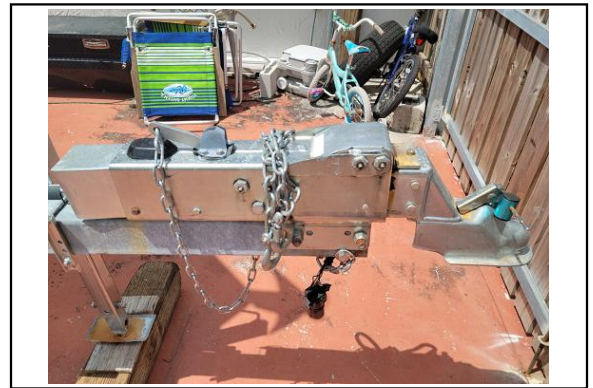
Coupler and Brake Actuator

Brakes are not operable. The system was removed. A new brake actuator was installed with a coupler. See picture.

FINDINGS	RECOMMENDATIONS
Brakes are not operable. The system was removed. A new brake actuator was installed with a coupler. See picture.	Investigate further and repair or renew as necessary.

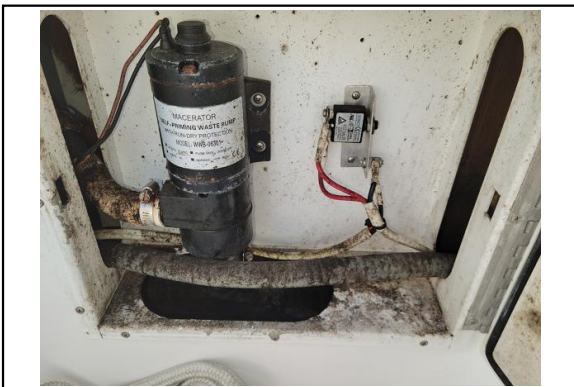
Macerator Pump for fish box

Both fish boxes are not working. One (1) of the macerator pumps (port) dies after running. The STBD side pump stays powers up, but does not have sufficient vacuum.

FINDINGS	RECOMMENDATIONS
Both fish boxes are not working. One (1) of the macerator pumps (port) dies after running. The STBD side pump stays powers up, but does not have sufficient vacuum.	Further investigate and repair as necessary.

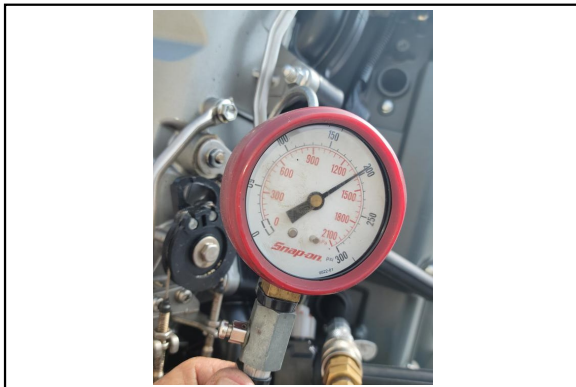
Cylinder Compression Reading

The Port engine Average Compression was 198 psi and the differences between cylinders was 7 psi. The STBD engine Average Compression was 205 psi and the Cylinder Compression difference between cylinders was 10 psi.

Note: Cylinder compression checks should not have a difference in compression reading more than 15 psi between the highest and lowest reading.

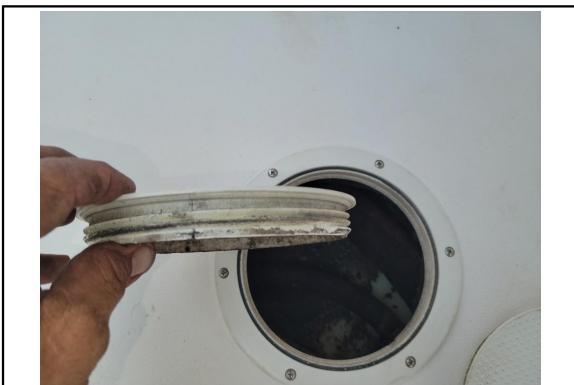
Gas Tank Deck Plates (4)

All four (4) gas tank deck plates are missing the o-ring. There is water intrusion signs on top of the tank around the sending unit.

FINDINGS	RECOMMENDATIONS
All four (4) gas tank deck plates are missing the o-ring. There is water intrusion signs on top of the tank around the sending unit.	Further investigate and repair as necessary.
