REPORT OF MARINE SURVEY

**Pre-purchase Condition and Value
of the bearing vessel**

Contender 27', Center Console-2000

Report file no:	000002
Inspection date(s):	July 11, 2019
Date of written report:	July 17, 2019
Conducted by:	Jorge Alberto
Requested by:	John Cartier 460 79 th Avenue NE ST. Petersburg, FL 33702
Purpose of survey:	To assess the overall condition and value of the vessel for pre-purchase decision making.
Intended use:	Recreational.
Vessel surveyed at:	Alex Acosta Marine Repair, Inc.
Weather conditions:	Sunny, warm with waves from 2 to 3 feet. Light winds.
How survey conducted:	The vessel was surveyed out of the water.
Sea trail:	Customer requested to perform sea trial by himself due to scheduling.
Electrical systems checked:	A multi-meter was used to check the DC electrical systems. There were no AC electrical systems sighted on board this vessel.
Surveyor's qualifications:	The surveyor is a member of ABYC (American Boat and Yacht Council) and MCTINA (Marine Career Training Institute of North America).

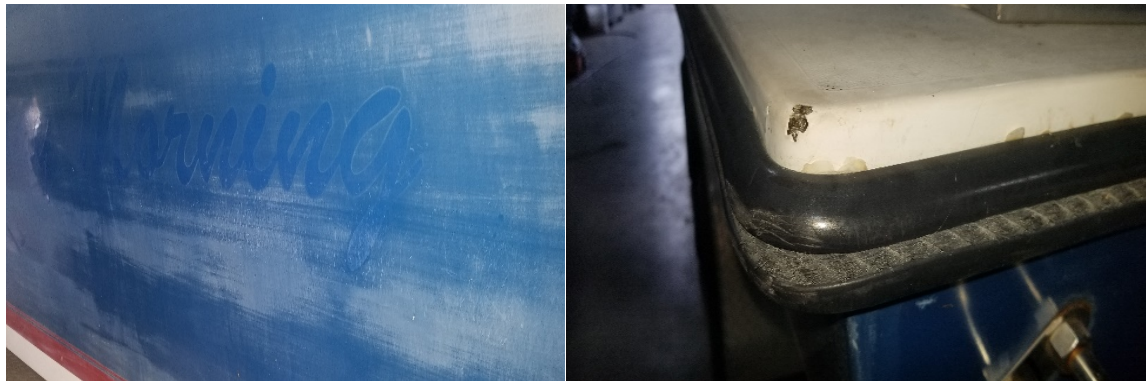
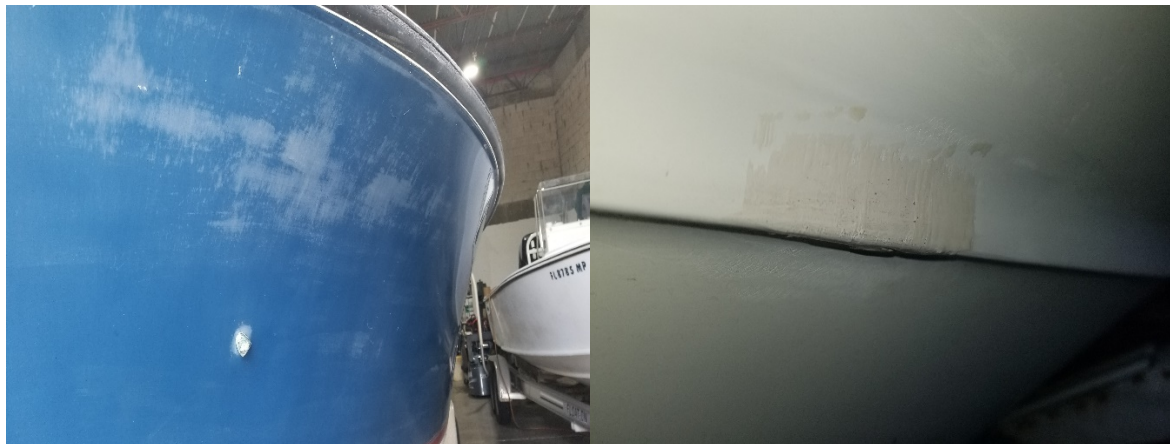
Construction material:	Fiberglass
Stem:	No stress marks on the external inspection. The thru-hull fitting is well secured to the hull.
Rub rail:	No movement noticed- secured.
Transom:	2" wide transom. No sign of laminate crushing at the engine bolts.
Hull cosmetic:	Lots of scratches, some chips, and the gelcoat has many areas that are oxidized.

*Lots of scratches, some chips and oxidation.

*Hull needs gelcoat repair, wet sand, and compound/wax.

* New decals will be needed.

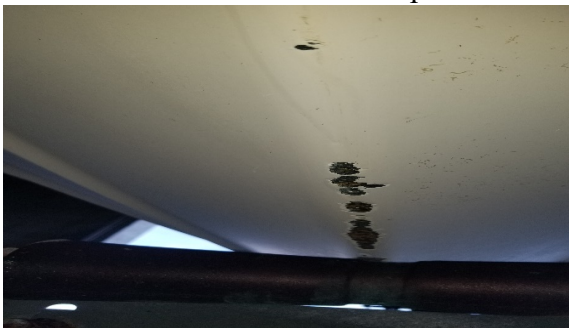
The keel has approximately 1' of gelcoat and possibly fiberglass repair needed.

*The keel has several gelcoat/fiberglass damage.

*Have a certified technician repair the keel.

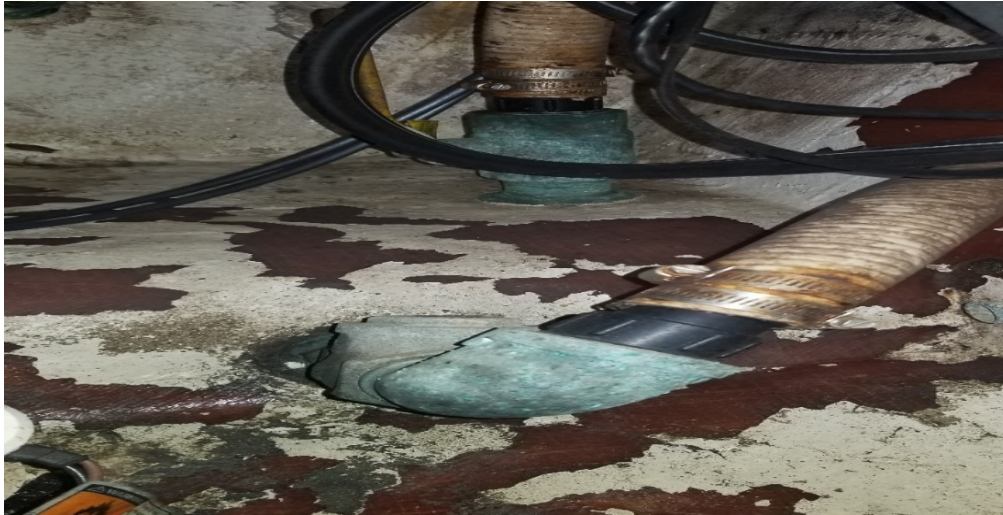
Bilge floor: Gelcoat has peeled.

*Interior gelcoat application on the bilge floor has peeled.

*Have a technician gelcoat paint bilge compartment floor.

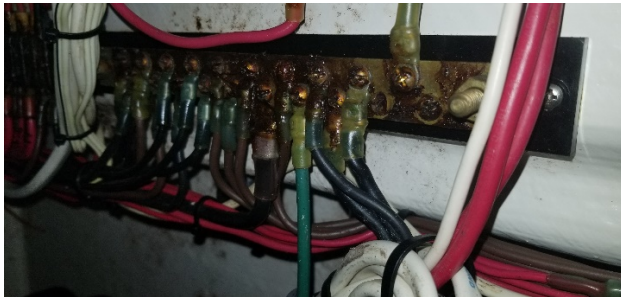
The bonding wire (green) was sighted connected to the negative bus bar and the main gas tank. No bonding wire was sighted connecting the thru-hull fitting and neither outboard engine.

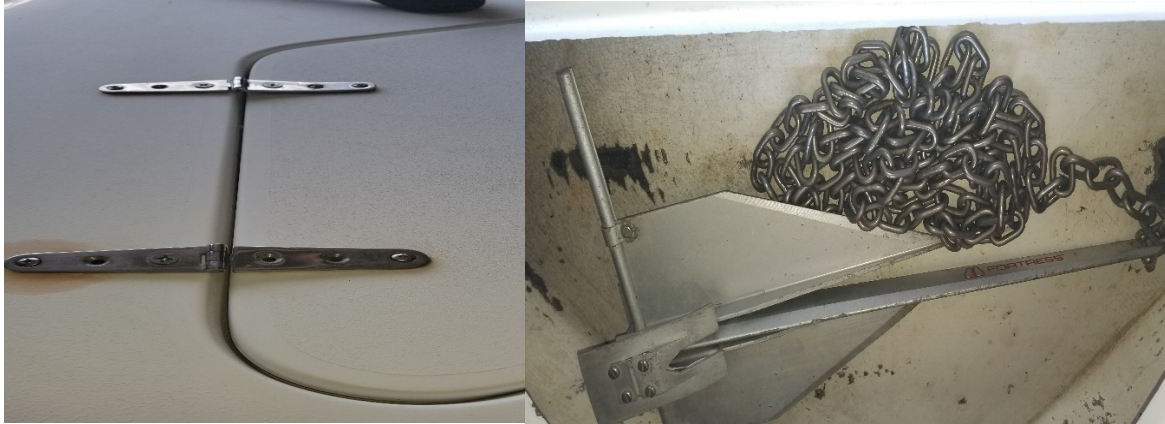
Anchor/chain locker: Deck hatch needs to be secured.

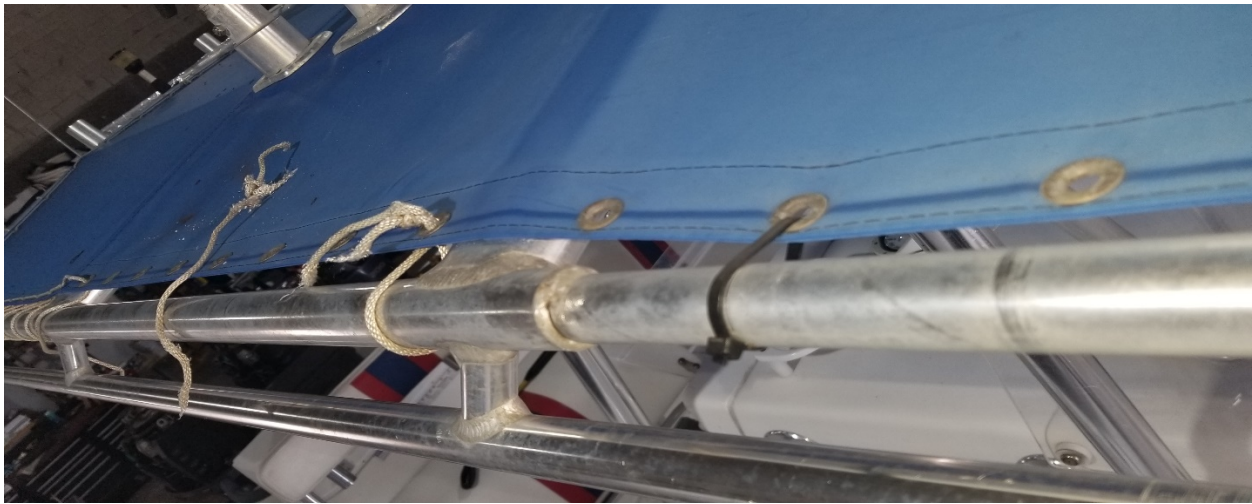
Canvas: The overhead T-Top canvas needs to be laced.

- *Hinges and latches need to be secured.
- *Canvas needs to be secured.

- *Have a qualified technician perform the repairs.

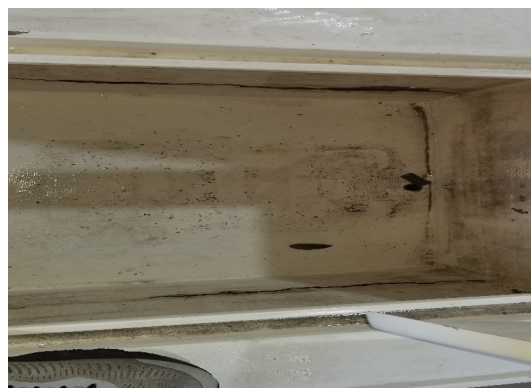
Fish box(es): Aft fish box in front of center counsel has delamination.

- *Rod holders need to be secured.
- *Fish box needs gelcoat repair.

- *Have a qualified technician perform the repairs.

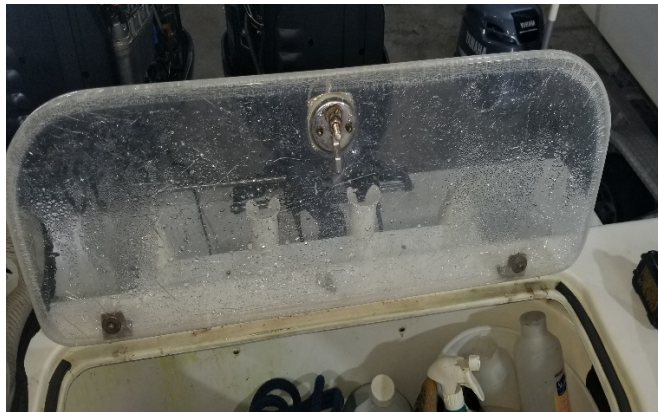
Live/ bait wells: Hatch door (plex-glass) is scratched.

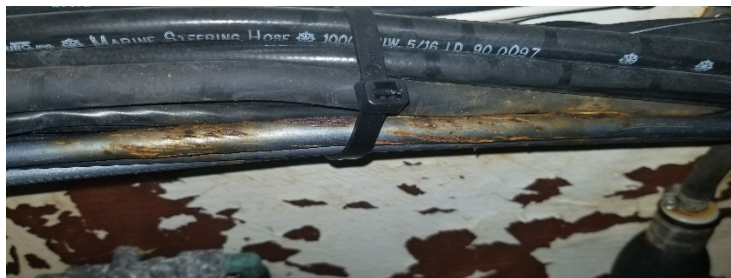
Throttle and shift controls: Port throttle control is stiff.

*Control cables need to be replaced.

Controls must be replaced.

*Have a qualified marine technician perform the repairs.

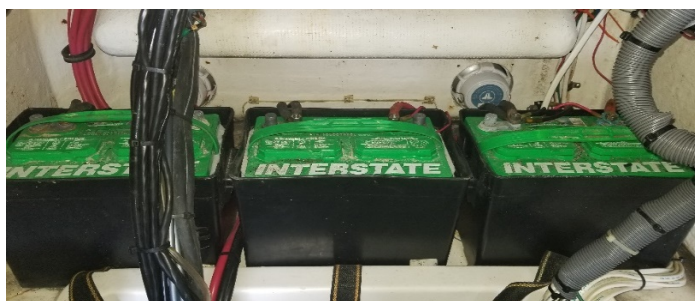
Three (3) Interstate Marine Batteries, SR- 29, are installed in the C.C. Secured in a closed battery casing as per ABYC E-10. Two (2) need to be charged. One (1) has a bad cell. A conductance tester was used to test:

12.47V	12.47V	9.43V
650 SAE	744 SAE	Bad Cell

- *One (1) battery needs to be replaced.
- *One (1) switch at panel needs to be replaced.
- *All battery terminals need to be serviced.

- *Have a qualified marine technician perform the repairs.

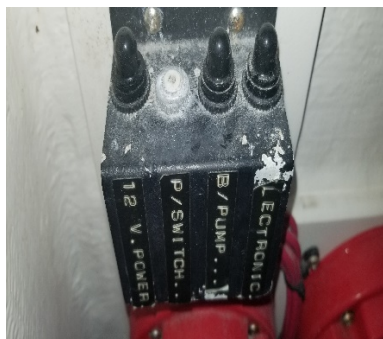
One (1) switch shorted at panel. One (1) push-bottom type relay frozen.

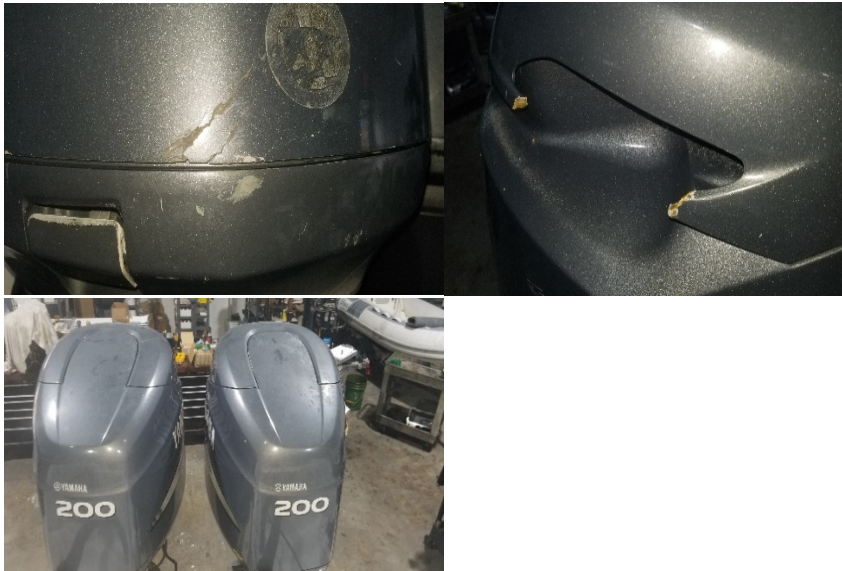
Fiberglass and gelcoat repair needed.

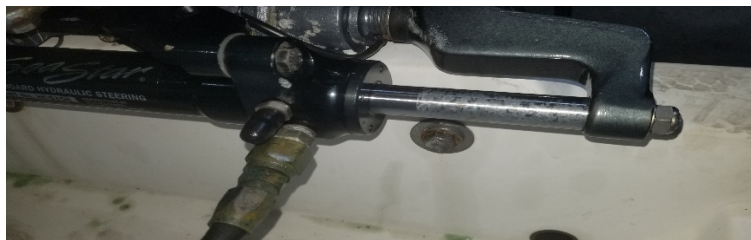
Mounting(s): One (1) single cylinder center mount made by SeaStar. Seals are in good condition. Chrome shaft has markings.

*No leaks. Even though the chrome shaft is marked.

*Monitor unit for leaks. Keep unit filled.

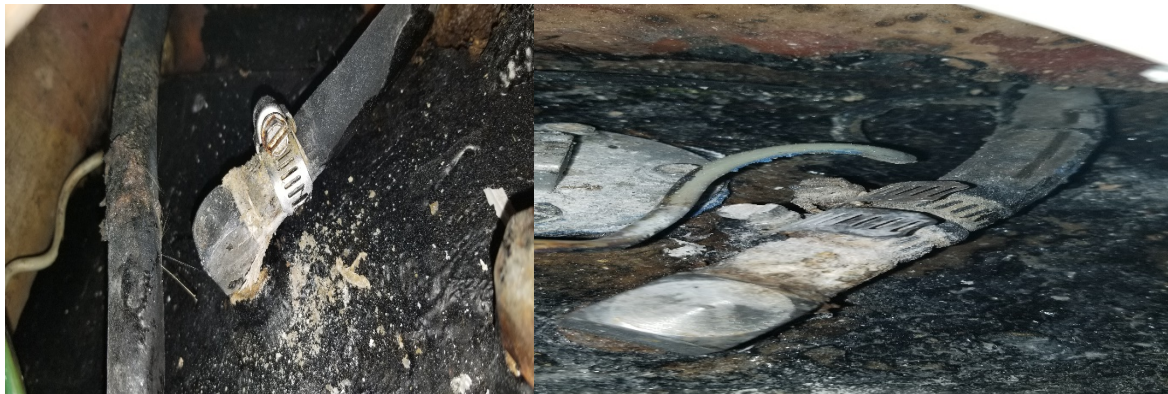
Corrosion needs to be removed at the fuel line pick-up fittings.

*Fuel tank feed line fittings have corrosion.

*Have a qualified technician service the fuel line fittings.
