REPORT OF MARINE SURVEY

**Pre-purchase Condition and Value
of the bearing vessel**

Hydro Sports 33', Cuddy-1989

**Jorge Alberto
on
August 22, 2019**

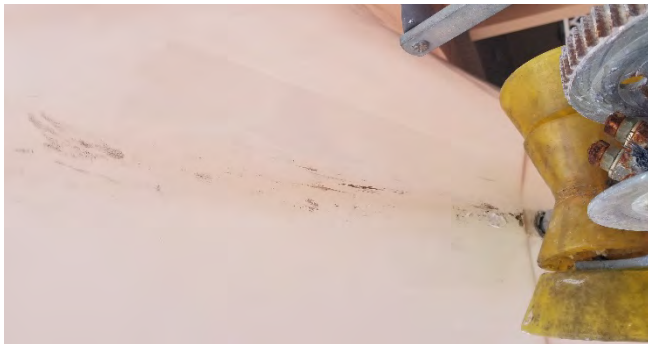
Stem:

Small cosmetic nick due to trailering. U bolt is secured and sealed.

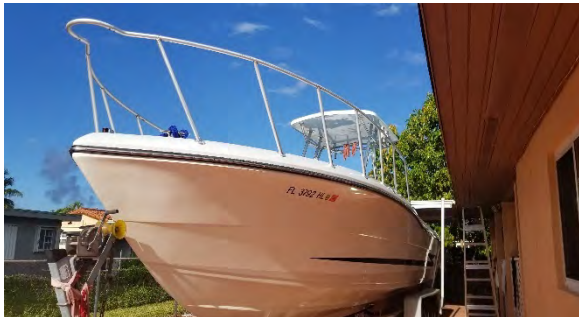
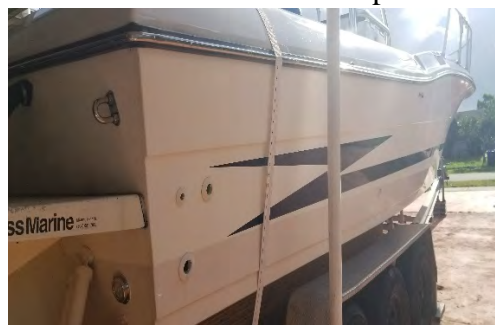
Hull cosmetic:

The hull was sounded with a phenolic hammer. No evidence of delamination. The hull was painted in 2017.

The striping on the side are painted.

Small scratches due to trailer.

Compound and wax gelcoat.

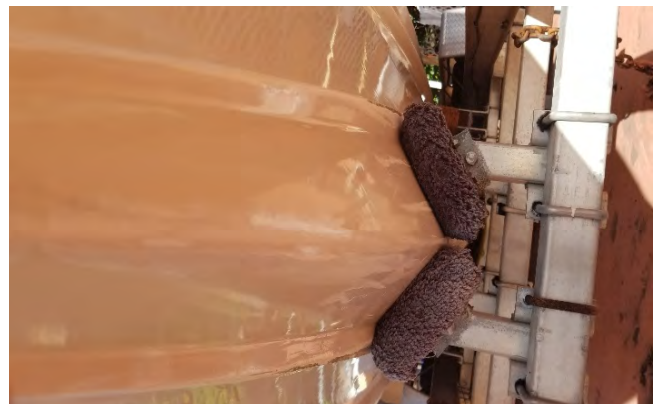
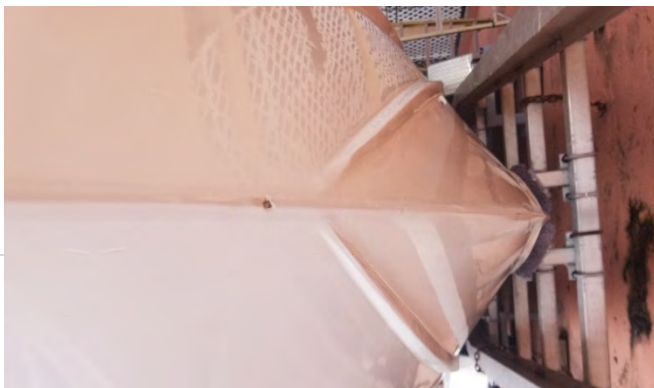
Grounding damage:

The front portion of the keel has minor scratches from the trailer.

Front portion of keel has minor damage due to the trailer.

Recommend compound and wax.

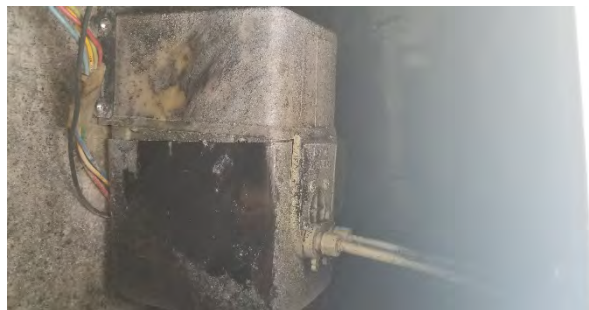
Trim tabs:

Hydraulic Bennett System. Motor sounds good. Actuators do not lower.

Unit is dirty from the restoration work in 2017.

Actuators do not lower.

System has to be filled with hydraulic fluid, in order to diagnose cause of actuators not

lowering.

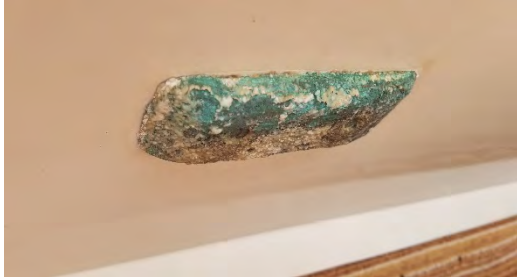
ANODES

The engine anodes have been replaced. The hull and transom anodes need to be replaced.

Hull and transom anodes need to be replaced.

Replace anodes during the annual inspection.

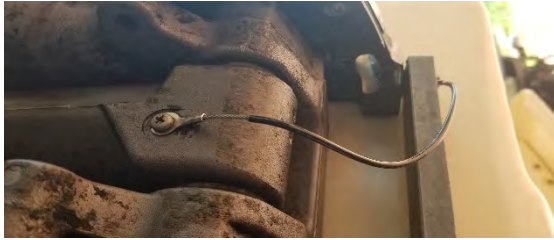
Bonding system:

No bonding wire were sighted at the negative bus bars or battery terminals. The fuel tank has no grounding either. The only bonding sighted onboard the vessel is at the engines.

No bonding system found onboard.

The bonding system needs to be restored. Connecting all metals to the negative bus bar and leading out to one of the engines anodes.

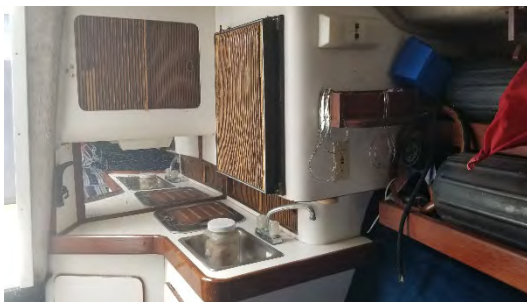
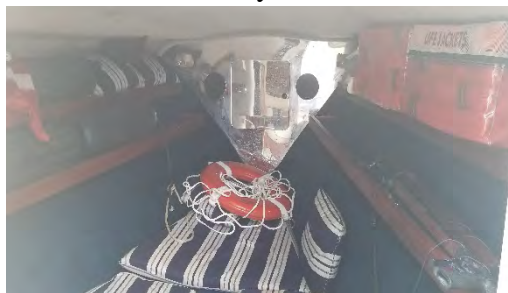
Cabin:

The electrical panel does not power up. The electrical DC and AC system needs to be repaired. No plumbing works because the fresh-water system needs to be replaced.

The fresh-water system needs to be replaced.
The sanitation system needs to be replaced.
Have a technician diagnose the panel.

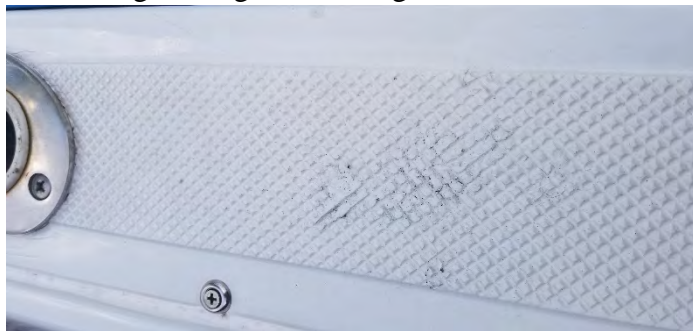
Gunwale:

The gelcoat grid is damaged.

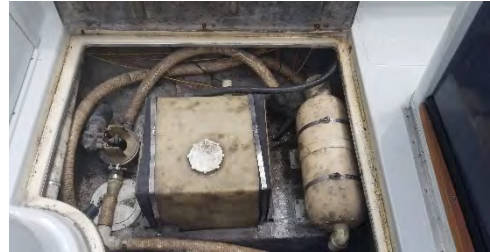
Bathroom:

Stand-up, not operable.

A new complete system is needed.

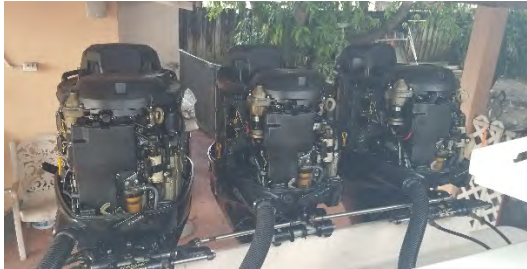
No./ Type/ Cylinders:

Three (3) four stroke Suzuki 250 hp. The PORT and STBD engines are 2006 and the CNTR is a 2008 (30" shaft).

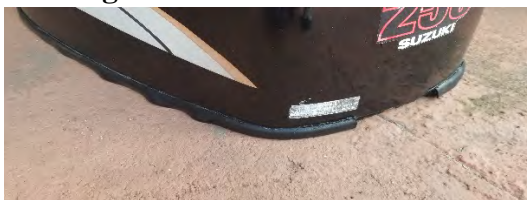
Cowling:

One (1) seal needs to be replaced. No nicks, painted well.

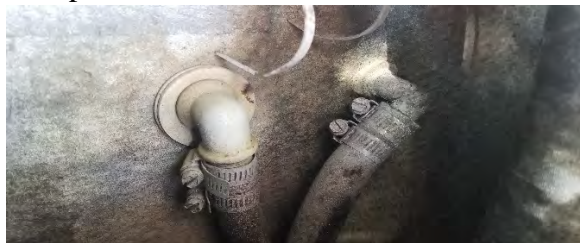
The tank has two (2) vents. The above vent should be replaced.

Note: Vent (air) restriction causes a fuel supply restriction. Possibly damaging the engine if not noticed in time.

Ground the tank and the fuel fill fitting.
Replace one vent.
A new system needs to be installed.
