## **Report of Marine Survey**

***ProKat 3660 Express***

**Catamaran**

May 16, 2021

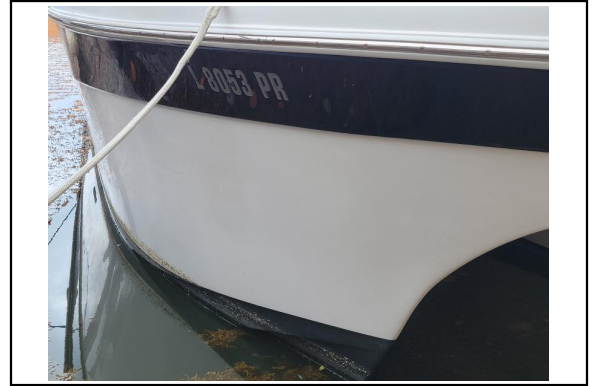
Hull Chocky-Needs Compound & Wax

STBD Side of Hull

FINDINGS	RECOMMENDATIONS
<b>B.1 (PAGE 4) HULL:</b> <b>The white gel-coat on the exterior side of the hull is choky.</b>	<i>Compound and wax hull.</i>
<b>B.2 (PAGE 15) LUBRICATION:</b> <b>The STBD engine has temperature warnings recorded, the engine oil is black( both engines) and the spark plugs have signs of condensation in the fuel (both engines).</b>	<i>Both engines need to have the 200 hour maintenance service performed, as per Suzuki scheduled maintenance service.</i>
<b>B.3 (PAGE 17) NOTE:</b> <b>The center cylinder seal (dust) needs to be replaced. Unit is not leaking, yet.</b>	<i>Recommend engine services to be performed by a trained outboard mechanic.</i>
<b>B.4 (PAGE 19) FUEL FILTER:</b> <b>Corroded bracket and filter.</b>	<i>Replace bracket and filter. In-order to avoid leak.</i>

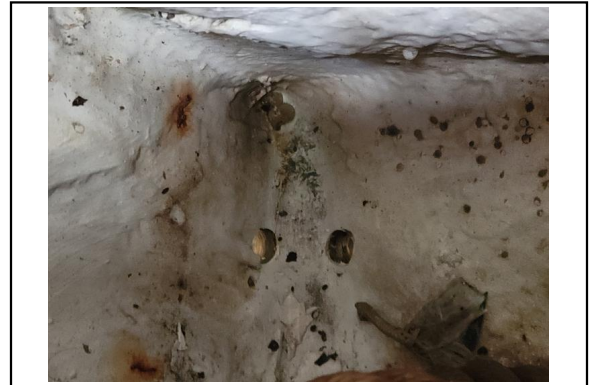
- \* CHAIN LOCKER (DRAINAGE): [C1] The chain locker is accessible through a hatch on the deck. The locker has plenty of space . The drainage holes in the locker are approximately 1/2" in diameter. Located in the center of the chain locker.

Gelco delamination in Bow Compartment

FINDINGS	RECOMMENDATIONS
<b>C.1 (PAGE 6) CHAIN LOCKER (DRAINAGE):</b> The drainage holes are in the center of the compartment. The water is accumulating and causing de-lamination on the side corners. Design defect.	Install weather strips on compartment door.
<b>C.2 (PAGE 17) &lt;User Define&gt;</b> Spark Plugs have signs of condensation.	Continue monitoring fuel (water separator clear bowl) for water after the 200 Hour Maintenance Service.

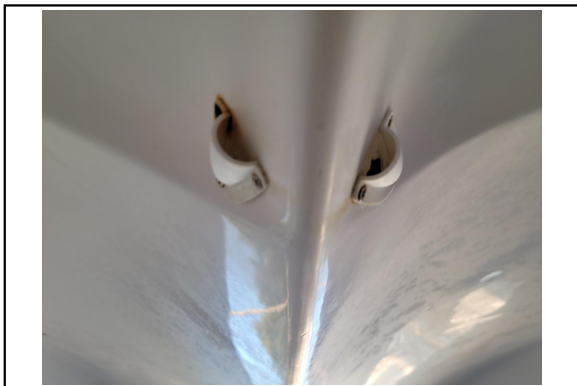
Limbol holes in the chain, anchor compartment

Limbol Holes for chain locker

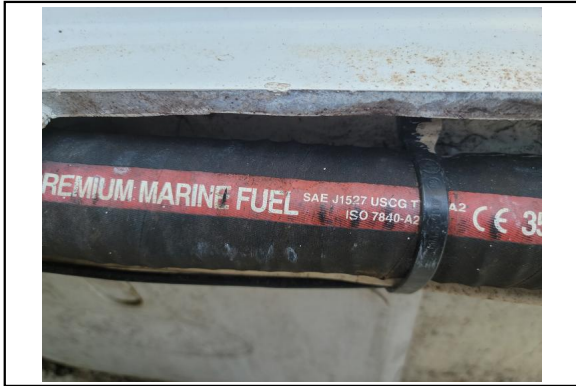
**FUEL LINES:** Fill and Vent Hose (only at tank location) was sighted to be doubled clamped. Fill Hose is grade USCG TYPE A2.

Fuel Fill Hose

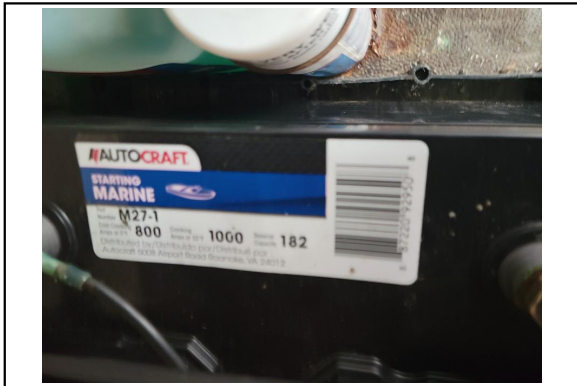
\* VOLTAGE/BATTERIES: [C3] 12 volts / Lead Acid Deep Cycle Batteries,. Grp 29

Battery with the correct spec's.

Three (3) of the four (4) batteries were under the engine manufactures battery capacity recommendation.

*Replace with correct spec's when needed.*

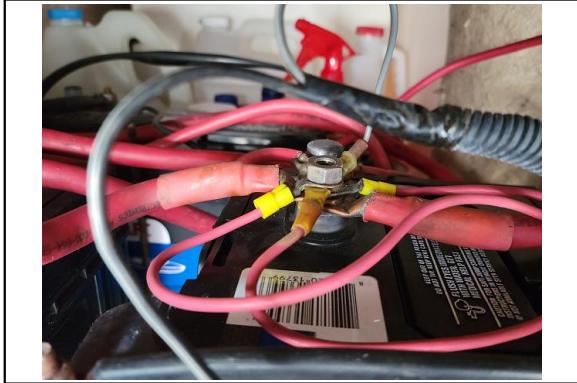
- \* **CONNECTORS/ROUTING/SUPPORT:** [B6] ABYC 10.8.4.1, A maximum of four (4) conductors terminals be permitted to be installed on a single battery stud.  
ABYC 10.8.3 , Battery cables and other conductors size 6 awg (13.3mm) and larger shall not be connected to be battery with wing nuts.  
ABYC 11.14.4.1.9.1, Conductors shall be supported throughout their length or shall be secured at least every 18 inches (455mm).  
ABYC 14.4.1.7, Conductors passing through bulkheads or structural members shall be protected to minimize insulation damage such as chafing or pressure displacement.

Excessive terminals on one post.

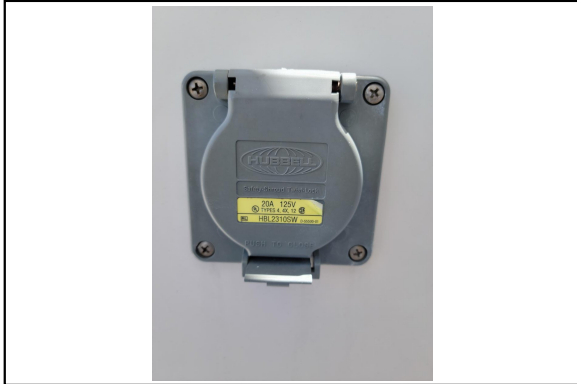
- \* **OUTLETS:** [B7] Two (2) AC outlets GFCI (ground fault circuit interrupter) in the cabin. One (1) tested ok for proper polarity Port side. The one in the STBD side failed.  
One (1) AC outlet 125 V / 20A. Weather protected (Hubbell)

**AC Outlet, 125 V**

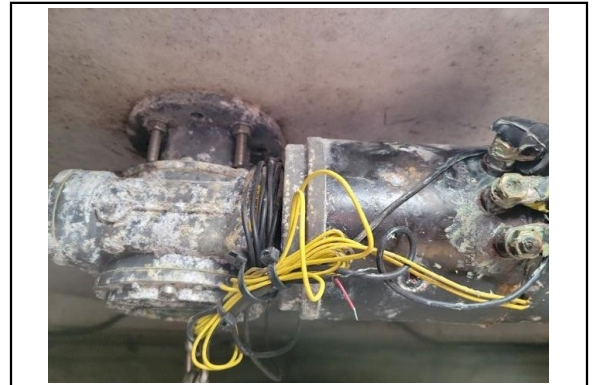
Winch Motor-Lewmar

Winch motor has some corrosion.

*Recommend to lubricate onboard machinery, wiring and hoses with Corrosion X Lubricant.*

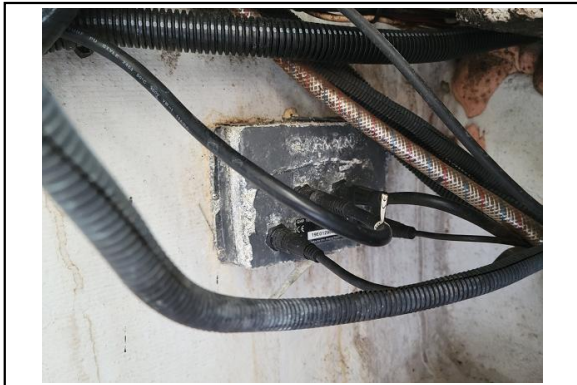
\* **AUTOPILOT: [B10]** Does not power up. Garmin, Pump 2.0 L appears good the module is corroded.

Autopilot Module

<b>B.10 (PAGE 28) AUTOPILOT:</b> Garmin auto-pilot module is corroded.	Investigate further and repair or renew as necessary.
<b>B.11 (PAGE 32) COMMENTS:</b> All anodes in the bottom of the hull are worn.	Investigate further and repair or renew as necessary.
<b>B.12 (PAGE 35) STRAINERS/SCOOPS/SCREENS:</b> Corrosion sighted on all thru-hull strainers.	Service bottom of the hull.
<b>B.13 (PAGE 37) OBSERVATIONS:</b> Temperature readings on the STBD engine reached 198 degree at WOT. A temp. of 203 degree activates a caution warning code.	A Full Maintenance Service recommended on both engines.

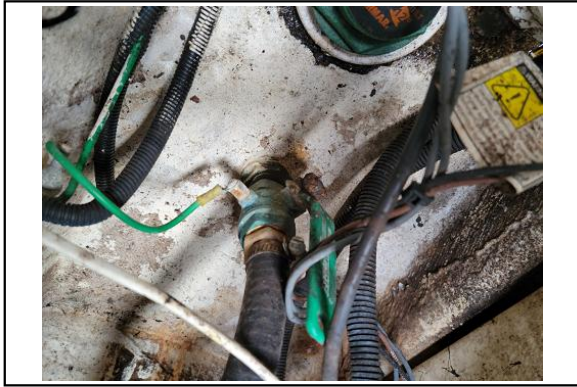
Thru-Hull Valve with Bonding wire

**CONDITION:** Gate Valves are frozen.

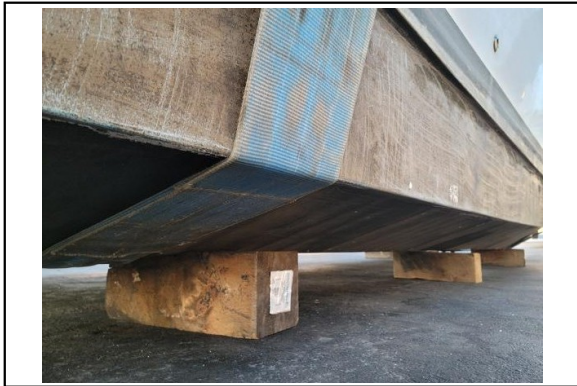
**CONDITION OF BOTTOM PAINT:** Poor condition, (see photos)

STBD Bottom Hull

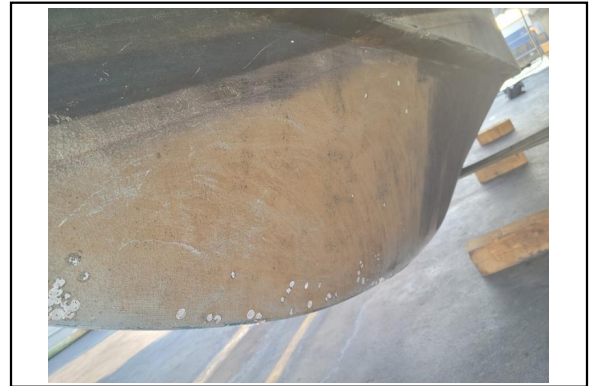
STBD Keel-NO BOTTOM PAINT
