JA OUTBOARD SERVICE, INC.
INDEPENDENT MARINE SURVEYING

Report of Marine Survey

Intrepid 339

Walkaround

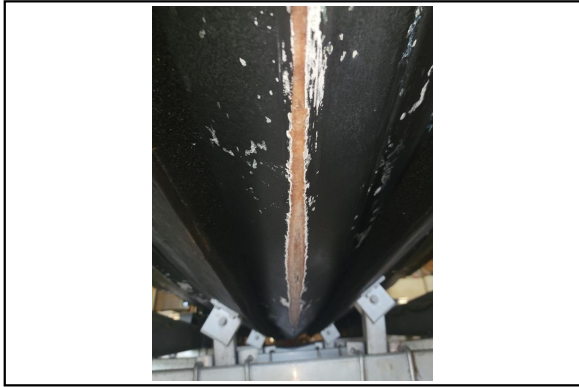
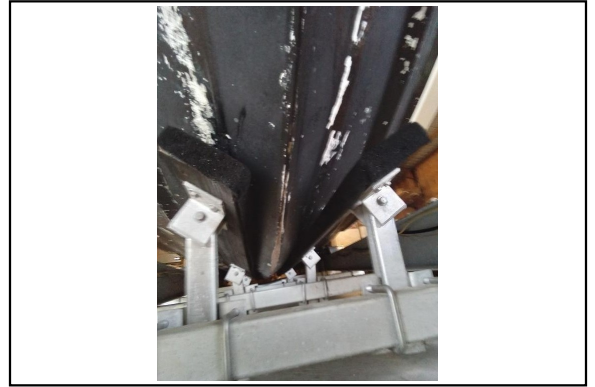
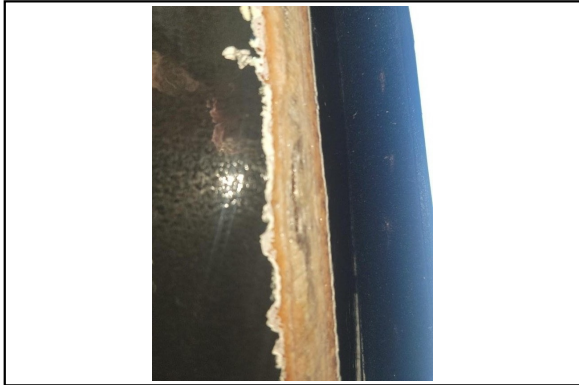
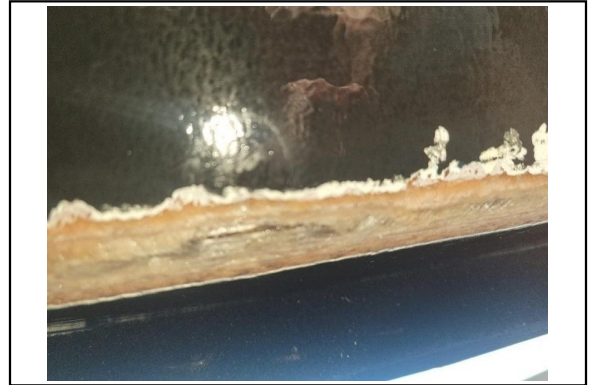
* **KEEL: [A1]** Ground damage is noted. The ground damage is a approximate 36" in length. There is 4 to 5 inches of soft material. De lamination is noticeable in the center.

There is approximate 32 inches of ground damage. In the center, there is 4 to 5 inches of soft material with delamination. Water was confirmed to be penetrating into the hull.

*Further investigate and repair with like kind materials in keeping with accepted marine repair practices.
The vessel should not be used until the repairs are made.*

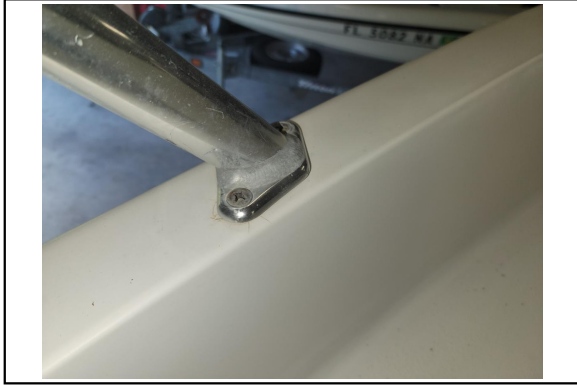
* **BOW PULPIT (BOW RAIL):** [B1] Stainless steel stanchions and rail system. Appears serviceable.
STBD side rail system needs to be better secured.

Bow Grab Rail-STBD Needs to be secured _085455

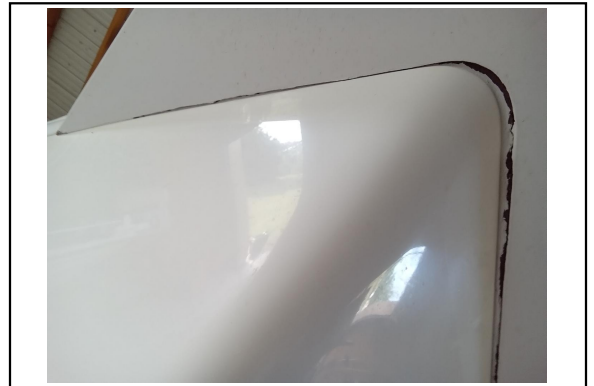
Puppit needs sealing

FINDINGS	RECOMMENDATIONS
C.1 (PAGE 9) ANCHOR PLATFORM: The anchor platform underneath appears to be missing sealant.	Further investigate and repair with like kind materials in keeping with accepted marine repair practices.
C.2 (PAGE 11) <User Define> Some corrosion on the trailer brakes.	Further investigate and repair with like kind materials in keeping with accepted marine repair practices.
C.3 (PAGE 19) MAIN BATTERY SWITCHES/LOCATION: Battery cables appear to be original-never replaced.

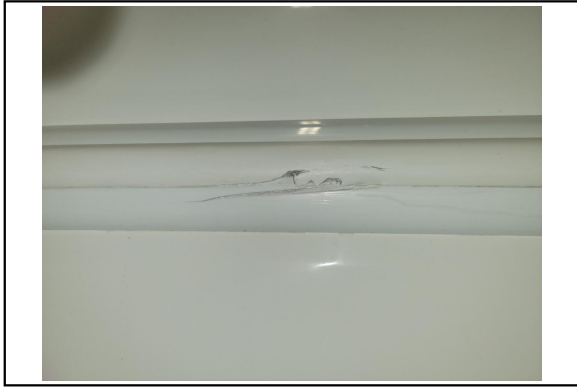
- * **<User Define> [B2] Rubrail:**
The rub-rail insert is damaged.

Rub Rail Insert Damage-STBD Side

FINDINGS	RECOMMENDATIONS
B.2 (PAGE 9) <User Define> The rub-rail insert is damaged.	<i>Investigate further and repair or renew as necessary.</i>
B.3 (PAGE 10) GENERAL EQUIPMENT: Refrigerators does NOT power-up.	<i>Investigate further and repair or renew as necessary.</i>
B.4 (PAGE 10) ACCESSORIES: The search light has one (1) bulb that does NOT POWER UP.	<i>Investigate further and repair or renew as necessary.</i>
B.5 (PAGE 11) <User Define> Non marine connection at trailer lights.	<i>Further investigate and repair with like kind materials in keeping with accepted marine repair practices.</i>
B.6 (PAGE 12) LIVE BAIT WELLS: Non Marine Connections are installed at the pump.	<i>Further investigate and repair with like kind materials in keeping with accepted marine repair practices.</i>
B.7 (PAGE 14) SINKS: Water Pressure very low from both sinks in the galley.	<i>Investigate further and repair or renew as necessary.</i>

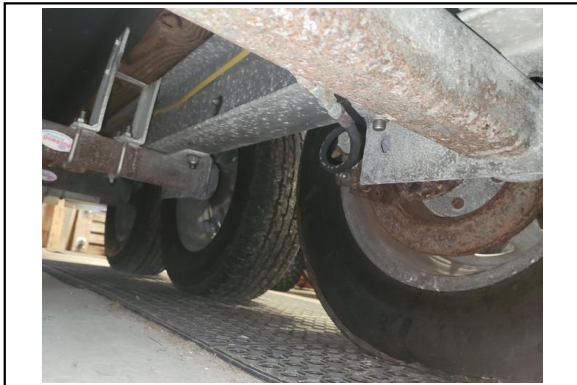
- * <User Define> [B5, C2] Corrosion is to a minimum.
Some corrosion on the trailer brakes.
Non marine connection at trailer lights.

Trailer-corrosion to a minimum, tire thread good,

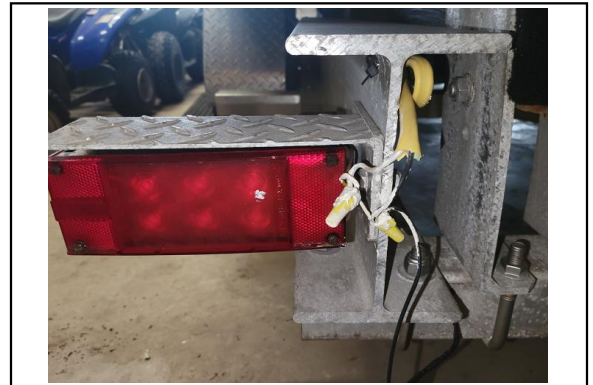
Non Marine Connection

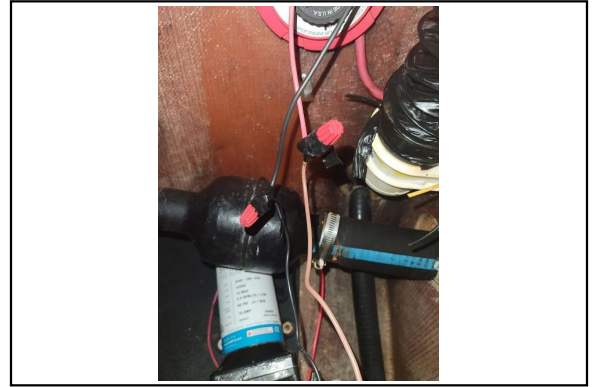
NON Marine Connection at baitwell pump

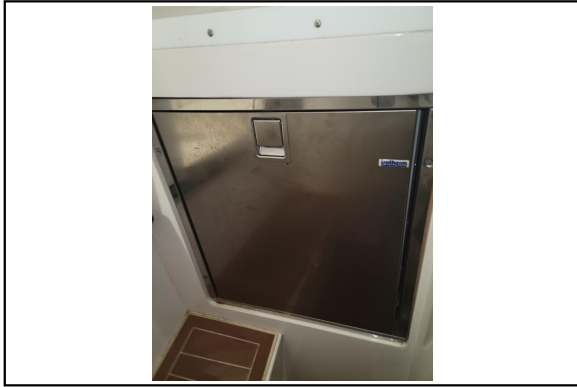
* **REFRIGERATION:** [B8] Stand alone refrigerator unit built into galley wall made by Isotherm. DOES NOT POWER UP

Refrigerator DOES NOT POWER UP

B.8 (PAGE 14) REFRIGERATION: Stand alone refrigerator unit built into galley wall made by isotherm. DOES NOT POWER UP	<i>Investigate further and repair or renew as necessary.</i>
B.9 (PAGE 17) MANUFACTURING LABEL: The gas tank label is not visible.	<i>Comply with ABYC H-24.18.5.4 Safety Regulations. The tank label shall be readable as positioned on the installed tank.</i>
B.10 (PAGE 18) SHUT-OFF VALVE: Corrosion sighted around the gas tank fittings.	<i>Further investigate and repair with like kind materials in keeping with accepted marine repair practices. Check bonding wire (green) connections and anodes (zincs).</i>
B.11 (PAGE 19) INSTALLATION/PROTECTION: The positive battery studs are not protected from accidental contact. More than four conductors are connected to one terminal.	<i>Comply with ABYC Regulations for Recreational Boats.</i>
B.12 (PAGE 21) M.S.D TYPE USCG SYSTEM: One of the straps securing the tank needs to be secured.	<i>Investigate further and repair or renew as necessary.</i>

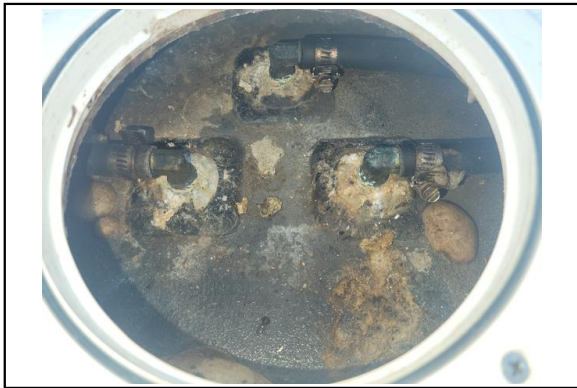
* SHUT-OFF VALVE: [B10] None Sighted.
Corrosion sighted around the gas tank fittings.

Gas Tank fittings-Corrision

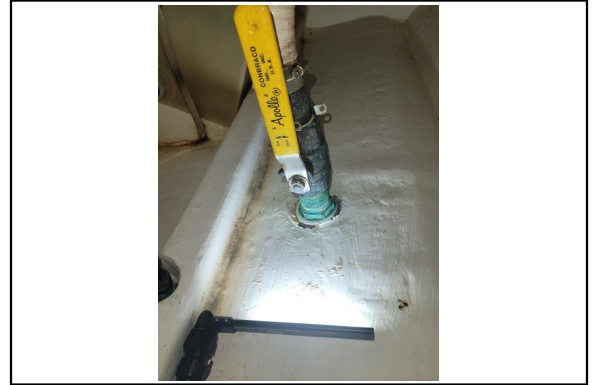
FROZEN thru-hull at Stern -Not in Use

Thru-hull Sanitation

FINDINGS	RECOMMENDATIONS
B.13 (PAGE 22) RAW WATER SUPPLY AND CLAMPS: Sanitation: No sign of water markings around thru-hull valve. It is FROZEN open.	Further investigate and repair with like kind materials in keeping with accepted marine repair practices.
B.14 (PAGE 22) "Y" VALVE(S): The Y-Valve is FROZEN.	Investigate further and repair or renew as necessary.
B.15 (PAGE 25) SPEAKERS: Both speakers do not sound good.	Investigate further and repair or renew as necessary.
B.16 (PAGE 28) LIST: The bilge pump at midship has non marine electrical connections.	Further investigate and repair with like kind materials in keeping with accepted marine repair practices.
B.17 (PAGE 28) TRIM TABS: Barnacles need to be removed-Pressure Wash.	Further investigate and repair with like kind materials in keeping with accepted marine repair practices.
B.18 (PAGE 29) ZINCS: The hull anodes need to be replaced.	Investigate further and repair or renew as necessary.

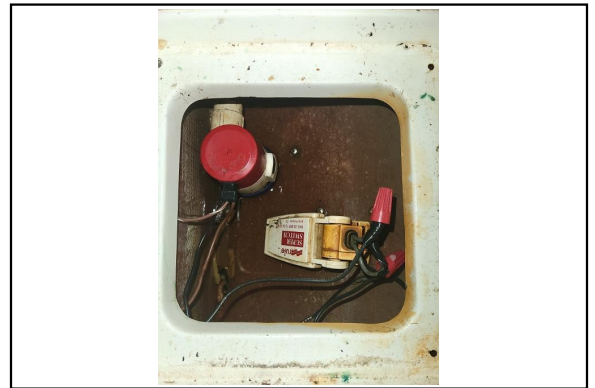
* **LIST: [B16]** Yes, one (1) midships Rule 90 GPH with remote float switch. And, two (2) AFT inside bilge compartment Rule 1500 GPH with remote float switches. Appears to be operable and serviceable. The bilge pump at midship has non marine electrical connections.

Bilge pump midship

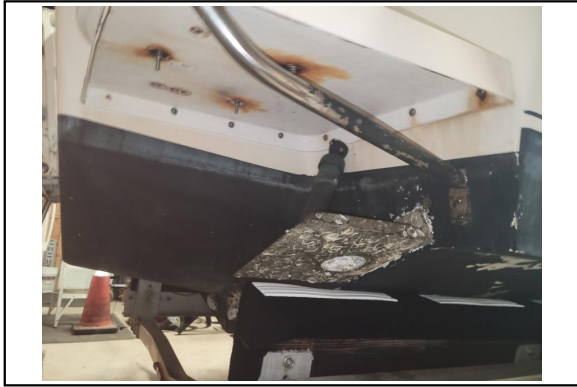
Trim Tabs need barnicles to be removed and

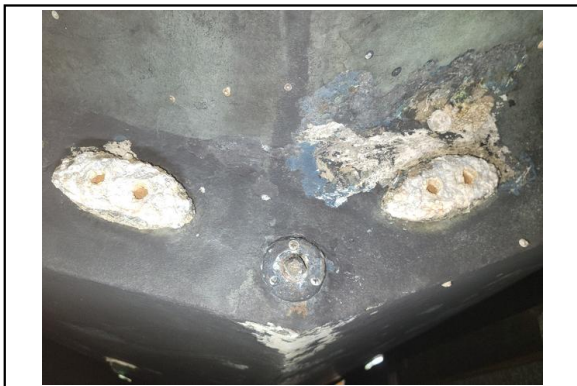
* **ZINCS:** [B18] Two (2) anode (zinc) sighted on hull at transom connected to bonding wire. And engine anodes (zinc) are connected to the bonding of the engine. The hull anodes need to be replaced.

Anodes (zinc) Hull

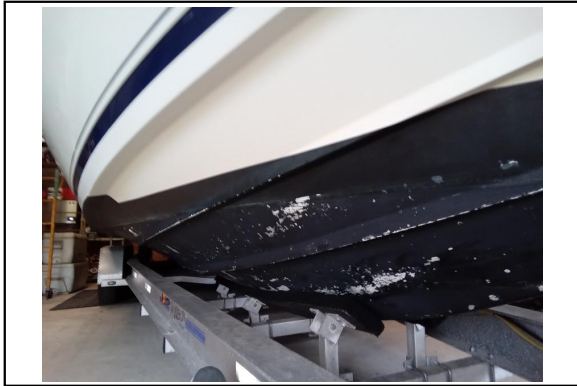
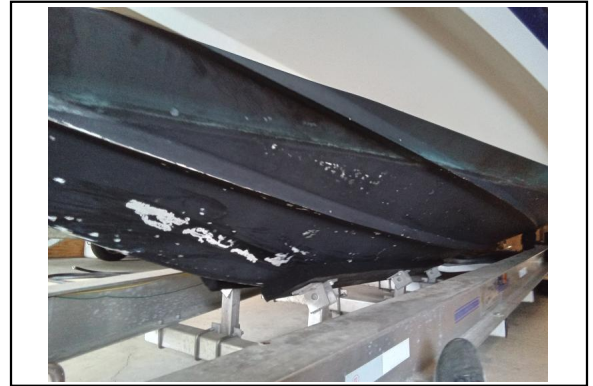
- * **CONDITION OF BOTTOM PAINT: [B20]** The bottom paint needs to be removed.
Poor condition, (see photos)

B.19 (PAGE 30) <User Define> The drain plug is frozen.	Investigate further and repair or renew as necessary.
B.20 (PAGE 30) CONDITION OF BOTTOM PAINT: The bottom paint needs to be removed condition is poor.	Further investigate and repair with like kind materials in keeping with accepted marine repair practices.
