JA OUTBOARD SERVICE, INC.
INDEPENDENT MARINE SURVEYING

Boston Whaler 370 Outrage

Report of Marine Survey

September 24, 2022

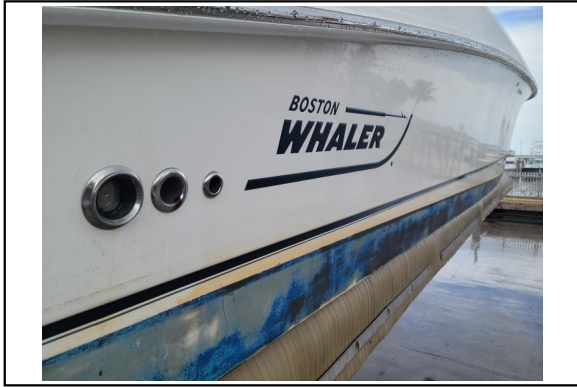
STBD Hull Side

<User Define> STBD Side Hull: The gel-coat has some yellow stains towards the AFT. No nicks, spider web cracks or any type of stress markings noticeable.

* **NOTE: [B1]** A full detail is recommended to restore several areas of the hull and superstructure that have yellow staining. The majority of the yellow staining can be seen around the transom and near the water line (AFT).

A full detail is recommended to restore several areas of the hull and superstructure that have yellow staining.

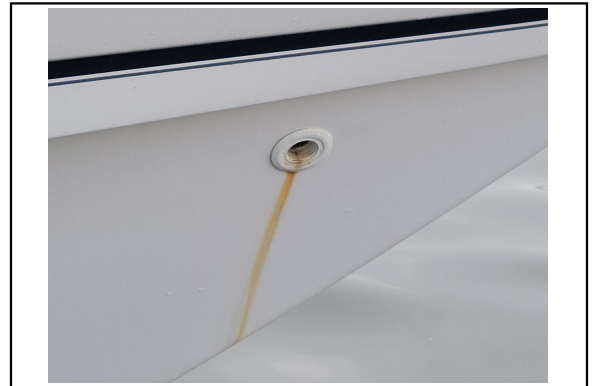
Port Bow Stain

<User Define> One of the port side thru-hull fittings has a yellow stain running down.

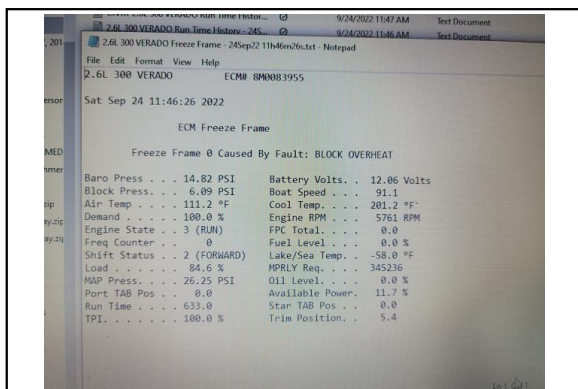
CNTR ENG. Fault History

Note: The only engine fault recorded in the CNTR Engine is the above that happen 10 hours ago, before the sea trial. The fault history report was retrieved on 9/24/2022, cylinder compression test day. The CNTR engine has 644 hours of operation.

No RUNNING engine fault was recorded during the sea trial.

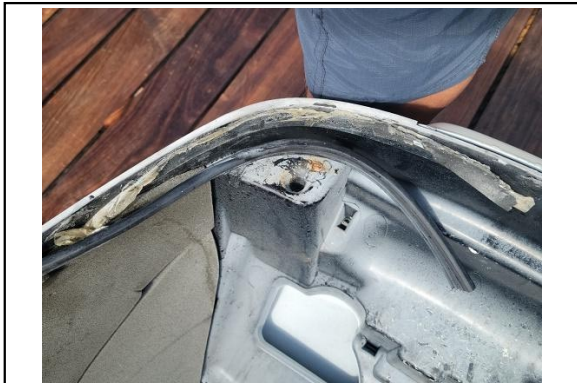
Engine Cover Seal

Note: The seal on one of the engines covers is damaged / worn.

The seal on one of the engines covers is damaged / worn.

Investigate further and repair or renew as necessary.

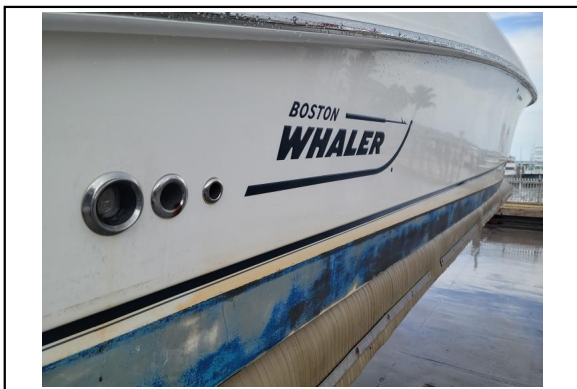
STBD Hull Side

* **CONDITION OF BOTTOM PAINT:** [B14] Bottom painted (black) approximately one year ago. Not prepared and applied correctly, (see photos)

B.13 (PAGE 32) STRAINERS/SCOOPS/SCREENS: Both scoopers are restricted with sea critters.	<i>Pressure wash both thru-hull gate valves to unclog passage.</i>
B.14 (PAGE 32) CONDITION OF BOTTOM PAINT: Bottom paint not prepared and applied correctly.	<i>Further investigate and repair with like kind materials in keeping with accepted marine repair practices.</i>
