JA OUTBOARD SERVICE, INC.
MARINE SURVEYOR ASSOCIATE

Center Console
Scout 275 lxf

Report of Marine Survey

February 16, 2024

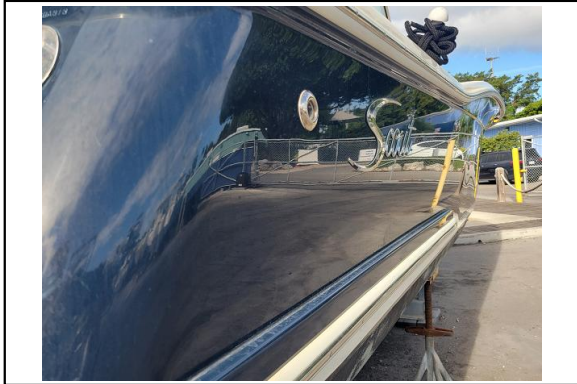
EXTERIOR HULL: No, Gel-Coat nicks, spider-web or blisters were found.
The Gel-Coat finish is maintained.

Stern STBD View

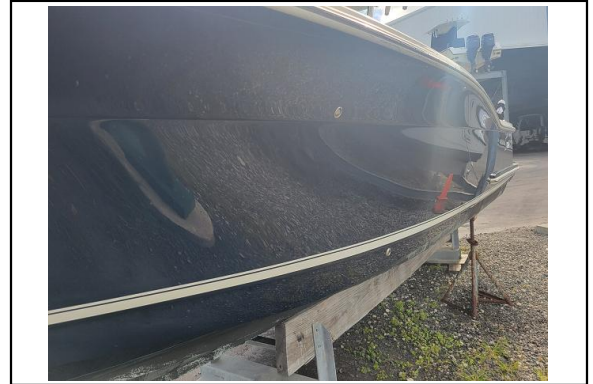
Hull Port View

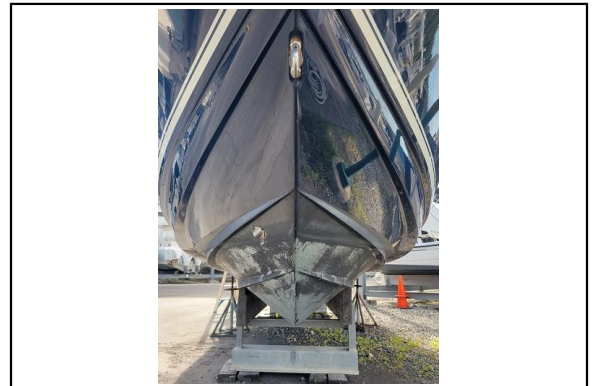
KEEL EXTERNAL: keel is solid.
Sounded keel with a phenolic hammer.

Keel

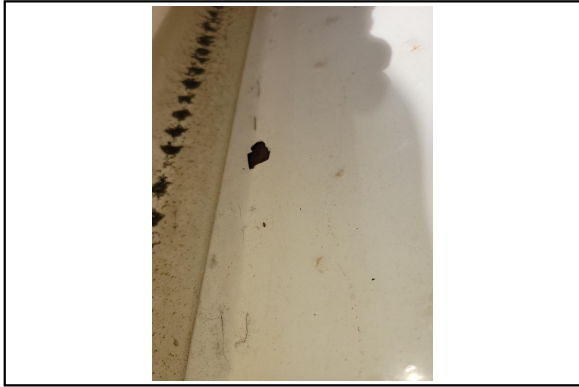
* **FISH BOX(S): [B1]** Two (2) fish boxes.
Gel-Coat chip and blisters on both fish box.

Gelco Chip at STBD Livewell.

FINDINGS	RECOMMENDATIONS
B.1 (PAGE 10) FISH BOX(S): Gel-Coat chip and blisters on both fish box.	<i>Investigate further and repair or renew as necessary.</i>
B.2 (PAGE 11) SINKS: Sink at AFT of CC did not Power-Up.	<i>Investigate further and repair or renew as necessary.</i>
B.3 (PAGE 13) INDICATED HOURS: The engine gauges are inverted.	<i>Investigate further and repair or renew as necessary.</i>
B.4 (PAGE 15) NOTE: Anodes on the lower unit and bracket need to be replaced.	<i>Investigate further and repair or renew as necessary.</i>
B.5 (PAGE 18) BATTERIES: Two batteries needed to be charged.	<i>Recommend to keep the boat charging system connected during storage.</i>
B.6 (PAGE 19) BREAKERS/FUSES: One (1) Breaker Corroded-Unwanted Open Circuit. Located in the bilge compartment port side.	<i>Investigate further and repair or renew as necessary with marine grade industry practice.</i>
B.7 (PAGE 23) NOTE: Sanitation System did not Power-Up.	<i>Investigate further and Repair or renew as necessary.</i>

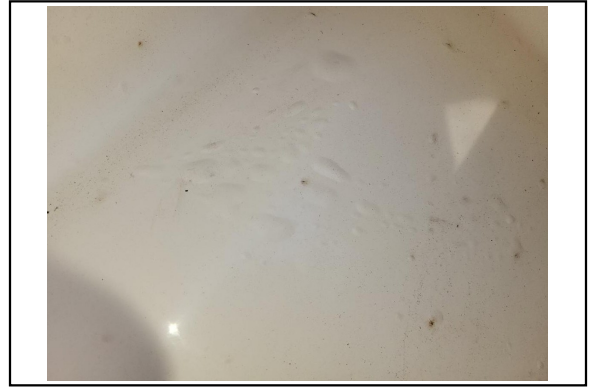
Gelco Blisters at Both Livewells

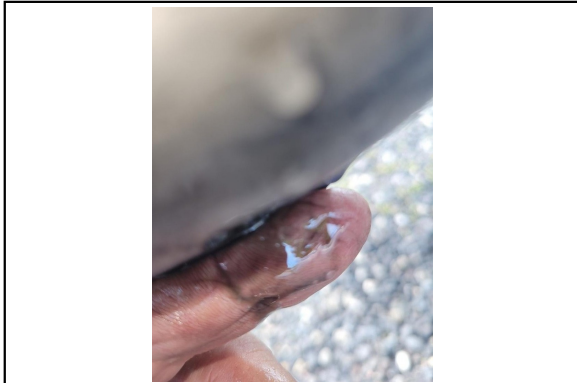
FLUID LEVEL AND CONDITION: NO, sign of water intrusion.

Gear Oil-NO WATER

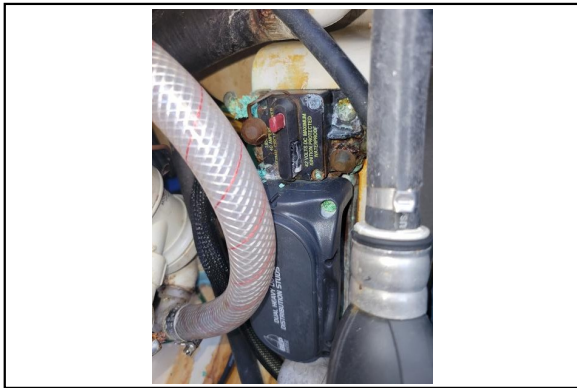
* **BREAKERS/FUSES:** [B6] One (1) breaker corroded. Needs to be replaced.
Located in the bilge compartment Port Side.

Electrical Relay CORRODED

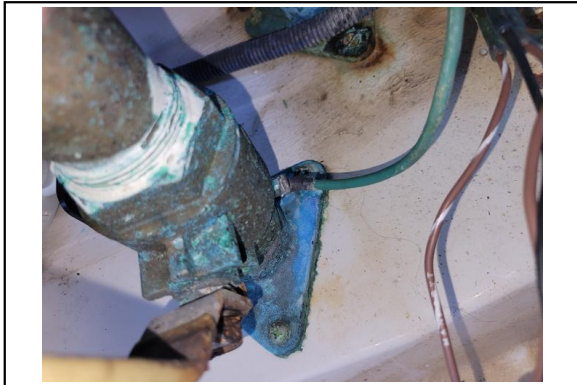
Bonding Wire at Thru-Hulls

CONDITION: Two are Operable the ones for the Livewells.
The other three (3) are frozen.

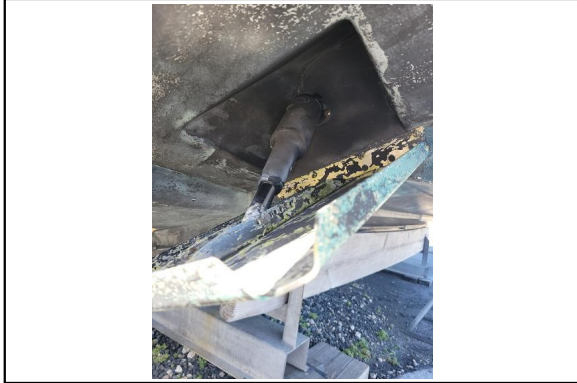
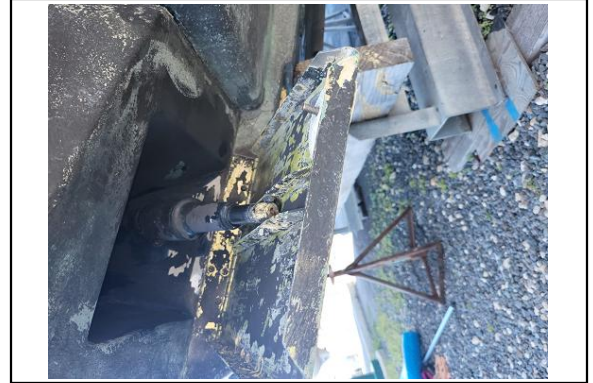
* ZINCS: [B10] One (1) anode on each trim tab. Need to be replaced.

B.8 (PAGE 31) SEARCH LIGHT: Powered-Up, but remote is damaged.	<i>Investigate further and repair or renew as necessary.</i>
B.9 (PAGE 32) STRAINERS/SCOOPS/SCREENS: Some corrosion on the thru-hull exterior fitting (bottom).	<i>Recommend to pressure wash.</i>
B.10 (PAGE 33) ZINCS: One (1) anode on each trim tab. Need to be replaced.	<i>Replace Anodes.</i>

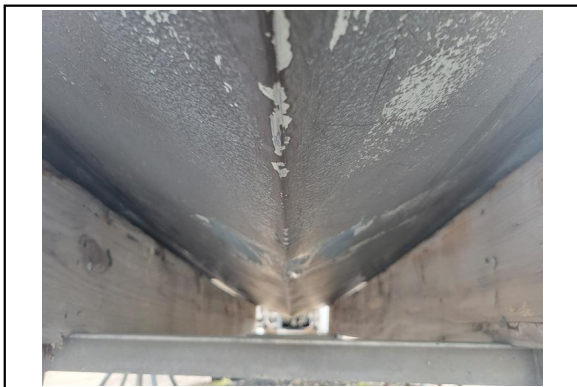
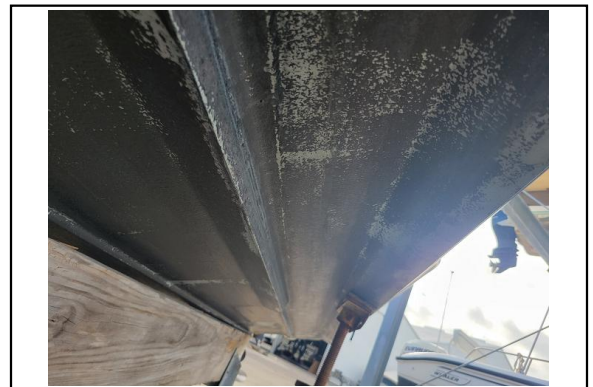
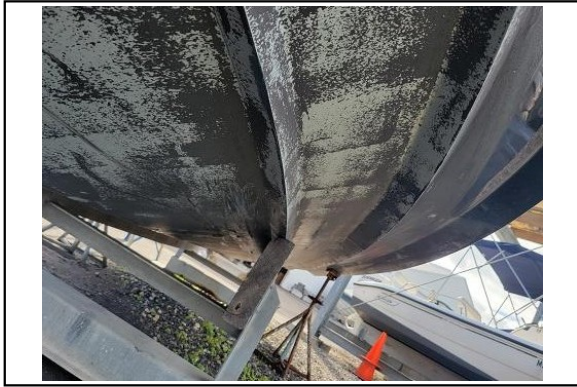
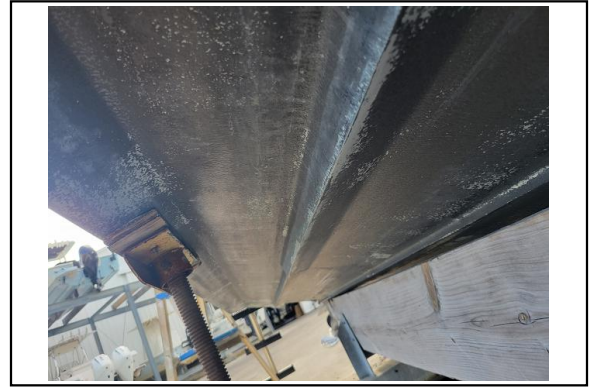
* **CONDITION OF BOTTOM PAINT:**[C3] The Bottom Paint is warn. The owner has not repaint the bottom, because the boat is kept in dry storage.
