Report of Marine Survey

Prokat

2660 Catamaran CC, 2007

April 20, 2021

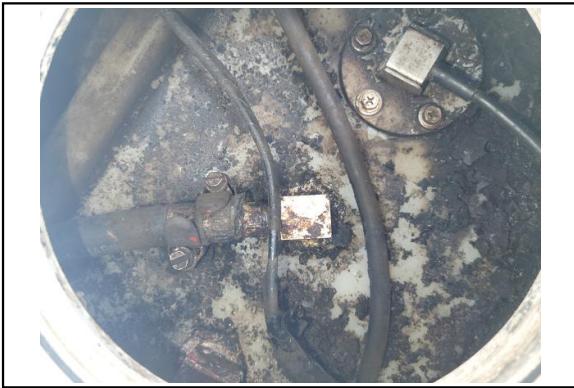
STBD Gas tank deck plate opening

***B.10**

All four (4) gas tank deck plates are missing the o-ring. There is water intrusion signs on top of the tank around the sending unit.

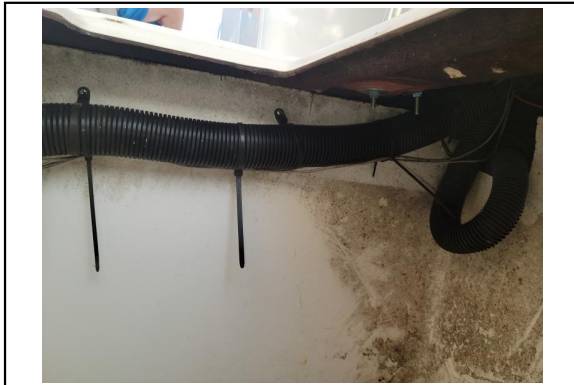
Secured and protected wiring

***B.16**

Wiring behind dash need more support.
