REPORT OF MARINE SURVEY

**Pre-purchase Condition and Value
of the bearing vessel**

Contender 27', Center Console-2000

Report file no:	000002
Inspection date(s):	July 11, 2019
Date of written report:	July 17, 2019
Conducted by:	Jorge Alberto
Requested by:	John Cartier 460 79 th Avenue NE ST. Petersburg, FL 33702
Purpose of survey:	To assess the overall condition and value of the vessel for pre-purchase decision making.
Intended use:	Recreational.
Vessel surveyed at:	Alex Acosta Marine Repair, Inc.
Weather conditions:	Sunny, warm with waves from 2 to 3 feet. Light winds.
How survey conducted:	The vessel was surveyed out of the water.
Sea trail:	Customer requested to perform sea trial by himself due to scheduling.
Electrical systems checked:	A multi-meter was used to check the DC electrical systems. There were no AC electrical systems sighted on board this vessel.
Surveyor's qualifications:	The surveyor is a member of ABYC (American Boat and Yacht Council) and MCTINA (Marine Career Training Institute of North America).

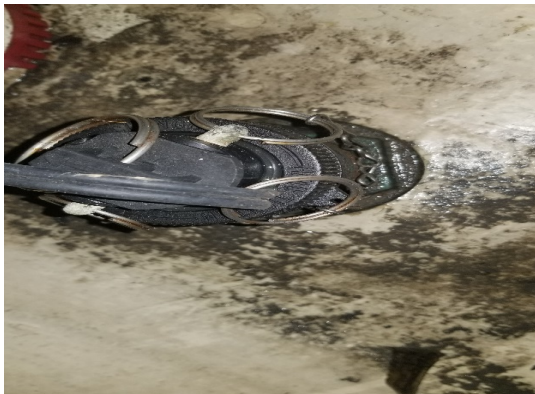
Thru hull fittings: No sign of delamination around the thru-hull fittings.

Transducer: Secured well.

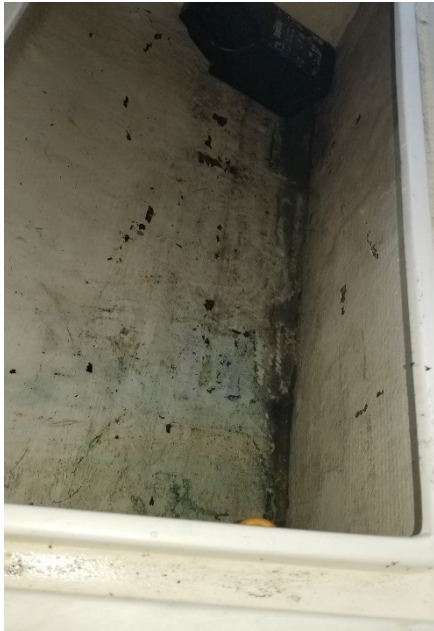
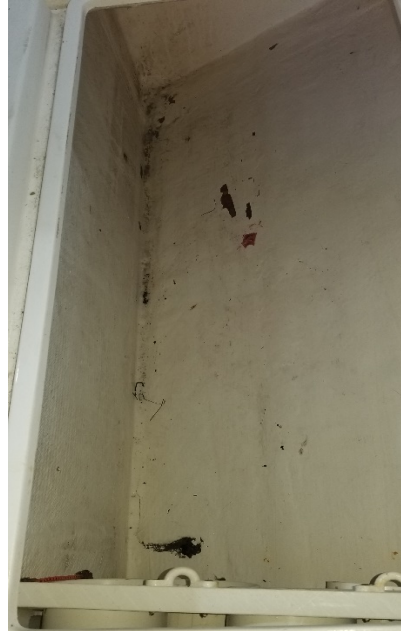
Stringers:

Solid, no sign of delamination.

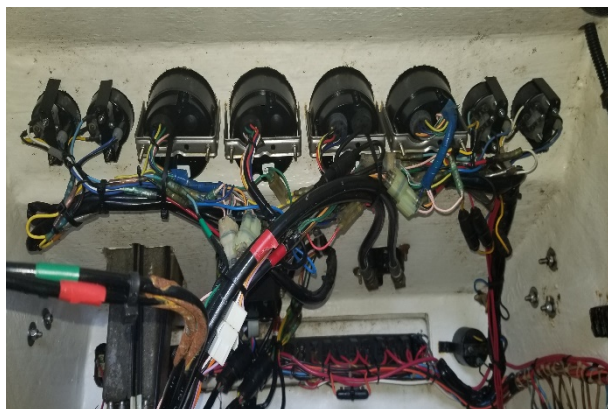
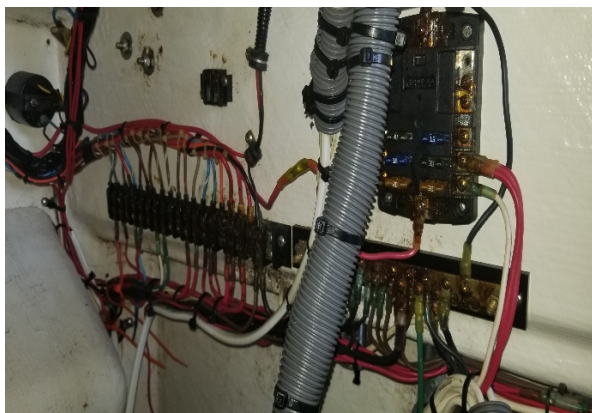
Wiring:

The boat was rewired in 2016. Several voltage readings were taken with a multi-meter at the bus bars, switches, and relays. All displayed battery voltage.

***Note:** Wiring is supposed to be secured every 18 inches. As recommended by ABYC E-11 recommendations.*

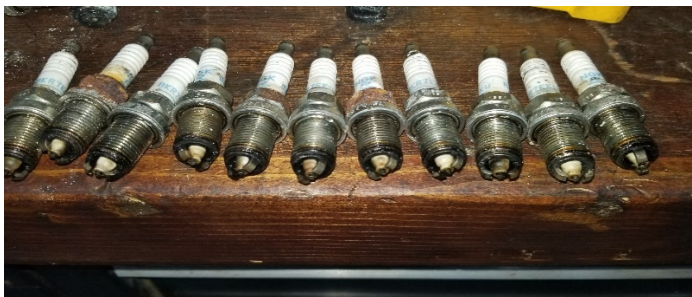
Spark plug coloration:

Consistent.

Note: After spark plugs have been run in an engine for a bit, their color is a good indicator of proper running. They should have a fully brown-beige or gray-tan coloration on the center electrode insulator.

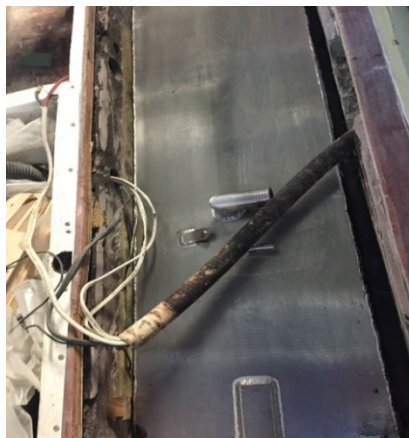
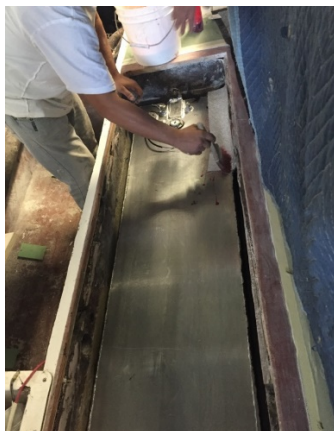
Tank type & capacity: Main tank 110-gallon and two (2) 50-gallon saddle tanks.

Tanks replaced in 2016. Pictures supplied by owner.

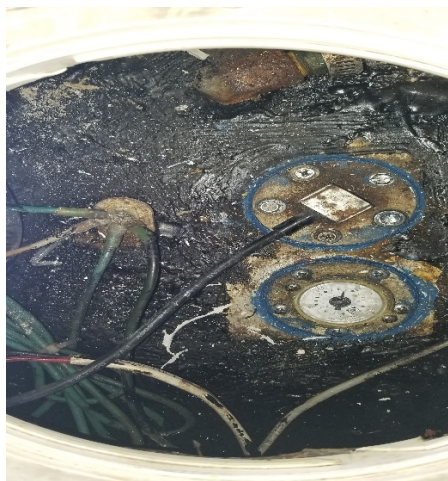
Fuel system grounding: All tanks grounded and the grounding wire (green) connected to the main tank.

Each metallic fuel tank and metal or metallic plated component of the fuel fill system, which is in contact with the fuel, shall be grounded so that its resistance to the boat's ground is less than one ohm. ABYC H-24-16.1.
