## **Report of Marine Survey**

***ProKat 3660 Express***

**Catamaran**

May 16, 2021

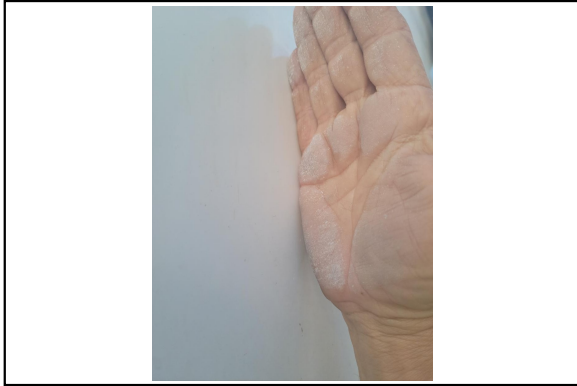
Hull Chocky-Needs Compound & Wax

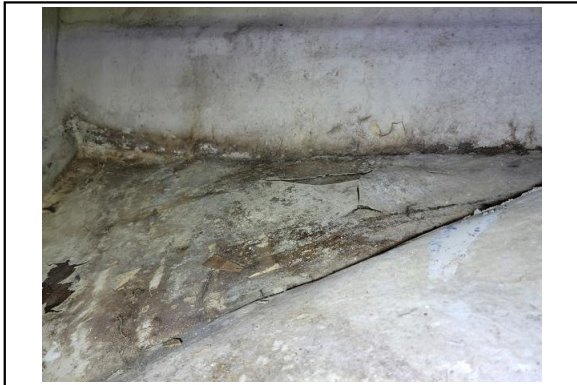
Gelco delamination in Bow Compartment

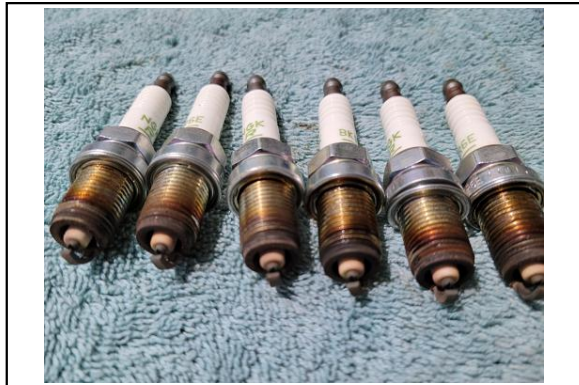
Spark Plugs (Port)

A consistent combustion throughout all the spark plugs reflex a tuned engine.

A gold looking color reflex water intrusion or condensation in the fuel.

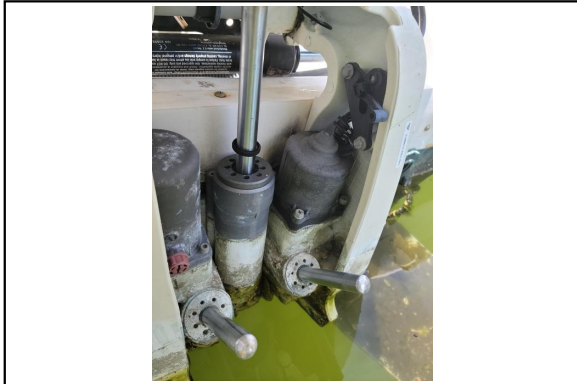
TNT STBD Unit

\* NOTE: [B3] The Trim & Tilt Unit STBD engine needs to be serviced / repaired.

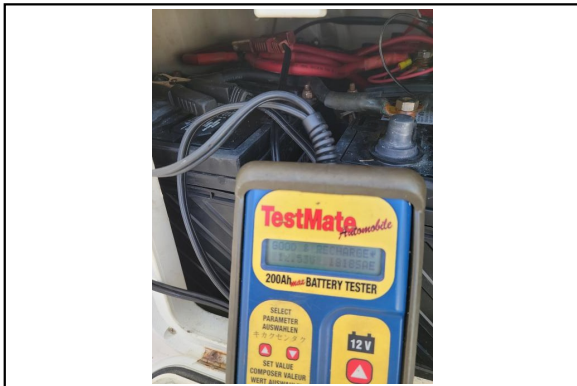
Battery Tester Readings

<User Define> All batteries tested.

Three (3) of the four (4) batteries were under the engine manufactures battery capacity recommendation.

*Replace with correct spec's when needed.*

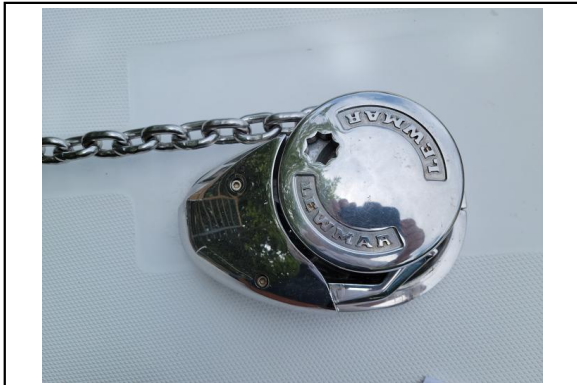
Lewmar Winch

Winch motor has some corrosion.

*Recommend to lubricate onboard machinery, wiring and hoses with Corrosion X Lubricant.*

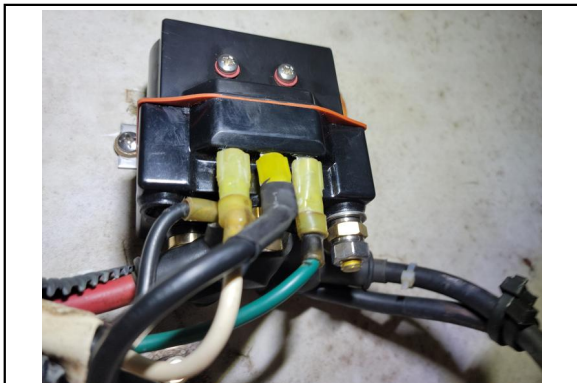
Winch Relay

<User Define> A new relay was installed.

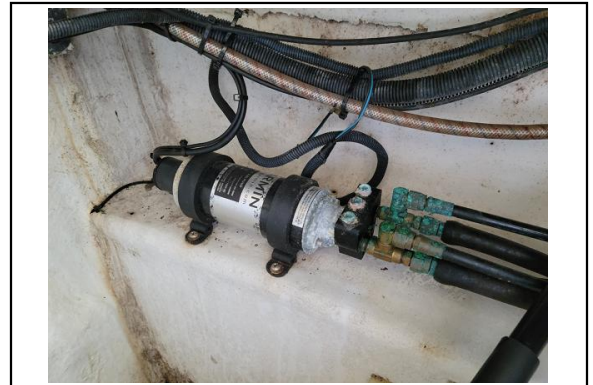
Autopilot Pump-Garmin

\* **AUTOPILOT: [B10]** Does not power up. Garmin, Pump 2.0 L appears good the module is corroded.

<b>B.10 (PAGE 28) AUTOPILOT:</b> Garmin auto-pilot module is corroded.	Investigate further and repair or renew as necessary.
<b>B.11 (PAGE 32) COMMENTS:</b> All anodes in the bottom of the hull are worn.	Investigate further and repair or renew as necessary.
<b>B.12 (PAGE 35) STRAINERS/SCOOPS/SCREENS:</b> Corrosion sighted on all thru-hull strainers.	Service bottom of the hull.
<b>B.13 (PAGE 37) OBSERVATIONS:</b> Temperature readings on the STBD engine reached 198 degree at WOT. A temp. of 203 degree activates a caution warning code.	A Full Maintenance Service recommended on both engines.

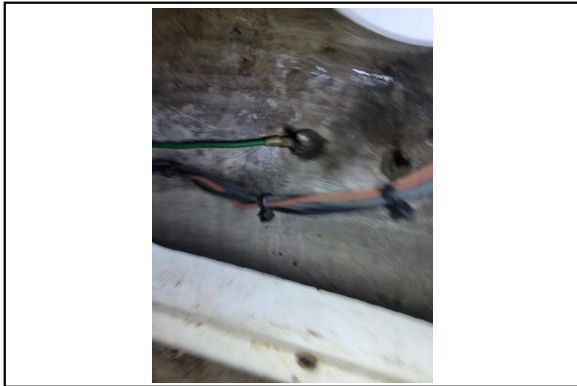
Bonding wire connected to external anode.

**MAIN BONDING CONDUCTOR:** The bonding system is mostly well established where sighted. A separate bonding system was not performed and I did not use a corrosion meter to establish the level of protection. However the bonding system is using individual green insulated wire and appeared to be serviceable where sighted. I also noted sacrificial anodes in the bottom of the hull. Monitor it frequently for condition and adequate protection.

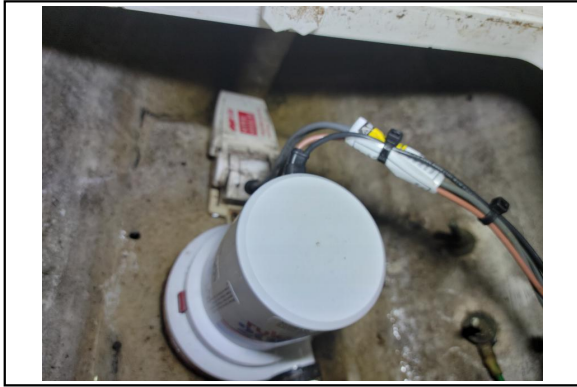
STBD Bow Bilge Pump

**NOTE:** The STBD side bilge pumps were replaced new.

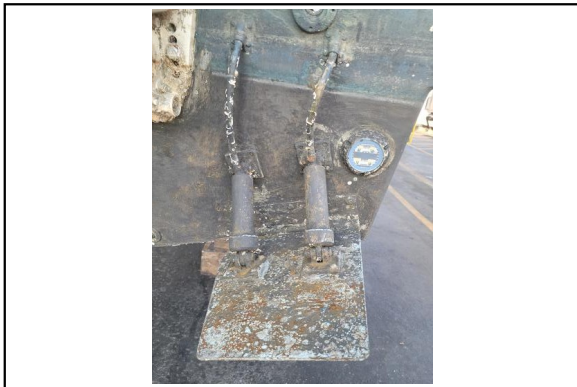
STBD Trim Tab

**TRIM TABS:** Motor (Boat leveler Co.) located at the aft of the boat bilge compartment.

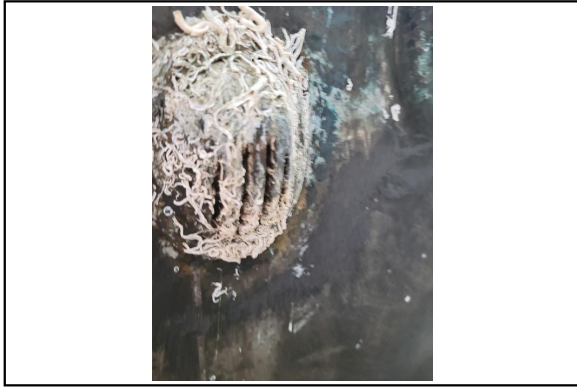
Thru-hull fitting

\* **STRAINERS/SCOOPS/SCREENS:** [B12] Thru-Hull Strainers are external bronze alloy slotted type.

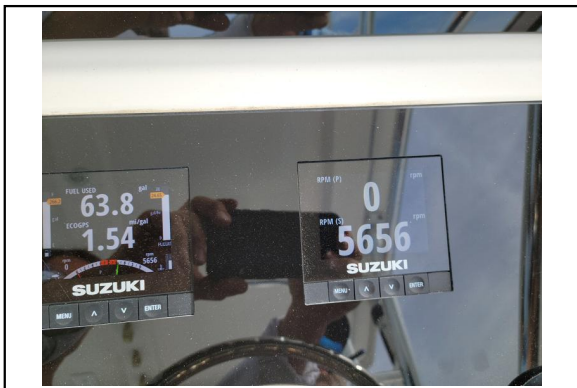
Suzuki Gauges-STBD Eng( WOT).

- \* **OBSERVATIONS: [B13]** \* The engine instruments operate within normal operating limits at idle, cruising speed, and maximum throttle.
- \* Engines reached 5650 at full throttle.
- \* The throttles operated normally.
- \* Temperature reading in the STBD engine reached 198 degree F ( 203 degree F. activates a caution warning code). The PORT engine operated within temperature range. Data was obtained from Suzuki Diagnose Software during the sea trial.
- \* The throttles operated normally.
- \* The transmissions operated normally/smoothly on both engines.
- \* The trim tabs operated normally.
- \* There were no oil or coolant leaks observed. On both engines or in the exhaust water.
- \* There were no excessive vibrations noted.
