JA OUTBOARD SERVICE, INC.
INDEPENDENT MARINE SURVEYING

Report of Marine Survey

Intrepid 339

Walkaround

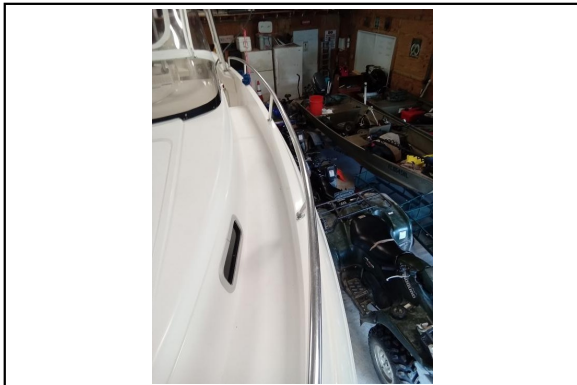
Grab Rail Port

* **BOW PULPIT (BOW RAIL):** [B1] Stainless steel stanchions and rail system. Appears serviceable.
STBD side rail system needs to be better secured.

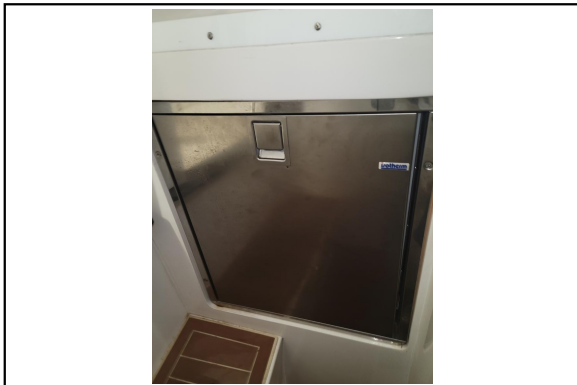
* **GENERAL EQUIPMENT: [B3]** One (1) refrigerators and one (1) cooler. The cabin refrigerator is by Isotherm and the cooler is made by Frigid-Rigid.
Refrigerators does NOT power-up.

Refrigerator DOES NOT POWER UP

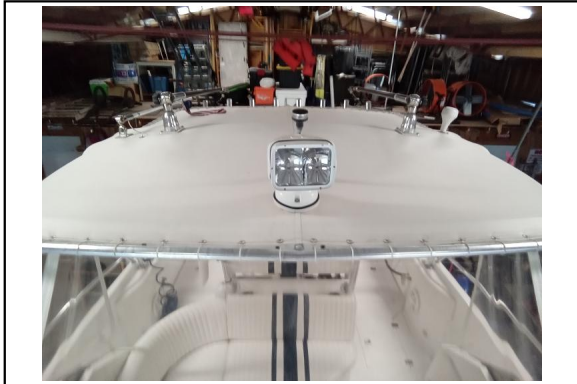
* **ACCESSORIES: [B4]** One (1) SEARCH light facing the bow, one (1) spreader light facing the AFT of the boat and two (2) cockpit lights. POWER UP
The search light has one (1) bulb that does NOT POWER UP.

Search Light Powered Up and rotates-BUT ONE (1)

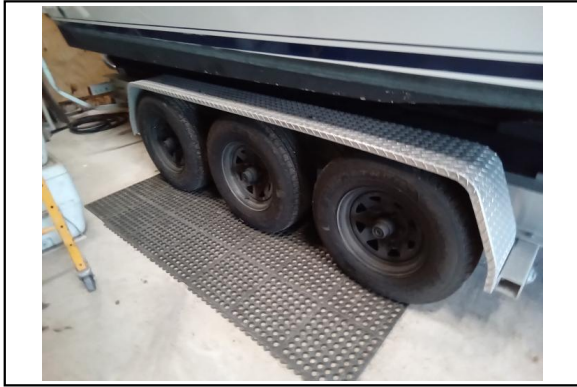
Trailer fenders, tires

- * <User Define> [B5, C2] Corrosion is to a minimum.
Some corrosion on the trailer brakes.
Non marine connection at trailer lights.

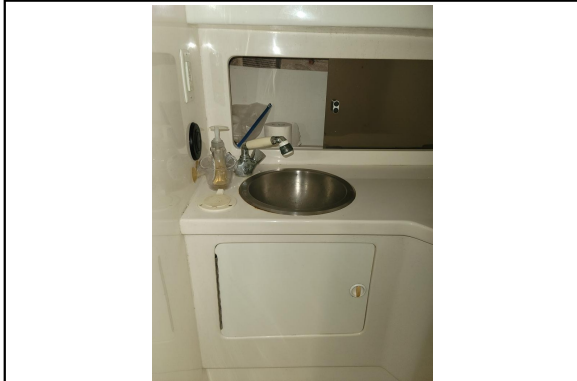
Sink (at head)

* **SINKS:** [B7] A single stainless steel rectangle shaped sink in the galley and oval shaped stainless sinks in the heads. Condition good.

Water Pressure very low from both sinks in the galley.

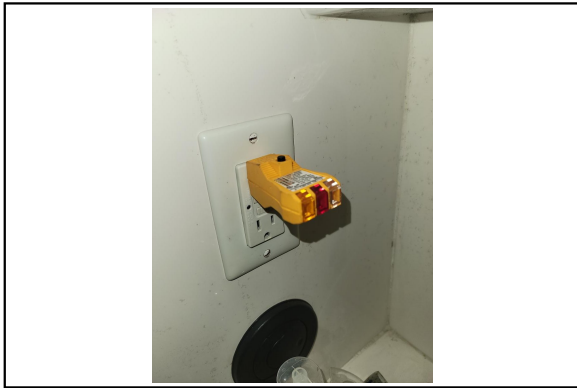
OUTLETS: Two (2) AC outlets GFCI (ground fault circuit interrupter) in the cabin. Both tested ok for proper polarity.

Outlet Tested

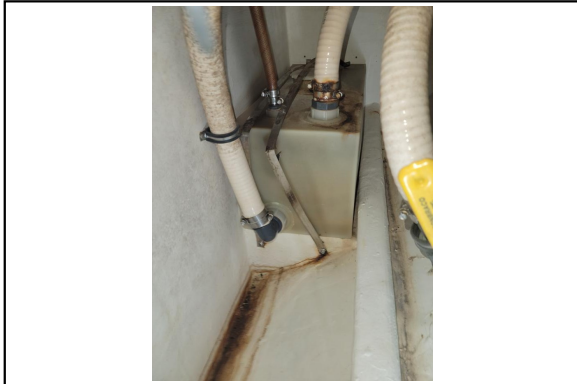
Sanitation Tank needs second strap to be secured

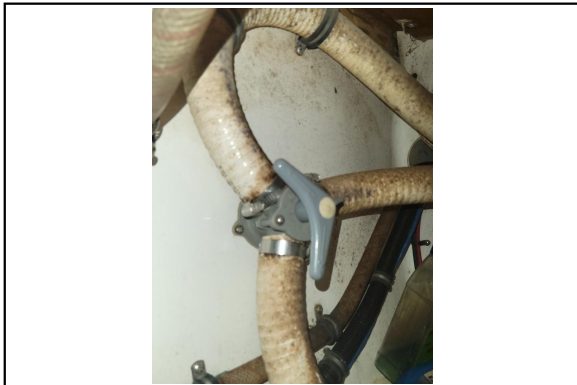
* **"Y" VALVE(S):** [B14] Yes, located STBD side of head. The Y-Valve is FROZEN.

Y Valve-Sanitation FROZEN

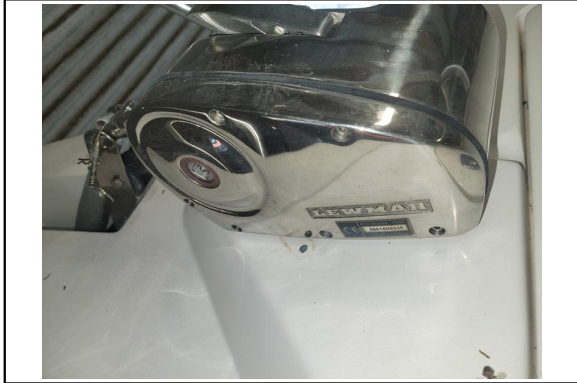
Windlassjpg

CONDITION AND DEFICIENCIES: Tested windlass when boat was on trailer. Operated well in both direction. Unit is secured structurally. No stress marks.

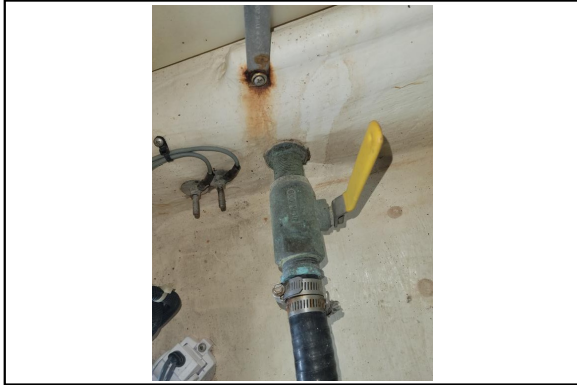
FROZEN thru-hull at Stern -Not in Use

CONDITION: All Valves are FROZEN.

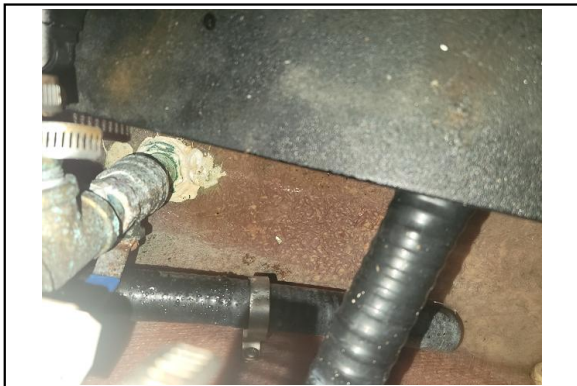
Live Bait-Well Thru Hull Valve

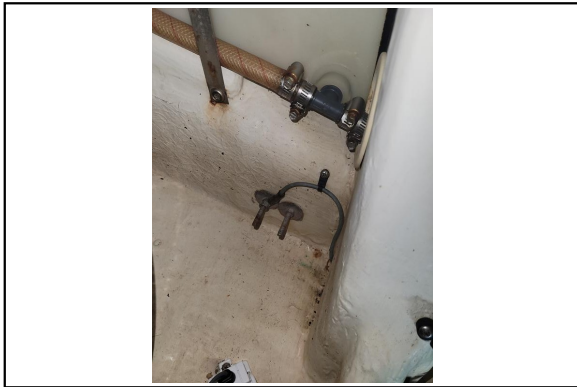
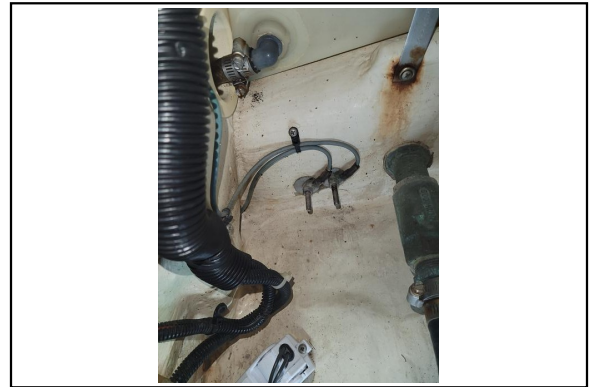
Note: The bonding system is mostly well established where sighted. A separate bonding system was not performed and I did not use a corrosion meter to establish the level of protection. However the bonding system is using individual green insulated wire and appeared to be serviceable were sighted. I also noted sacrificial anodes in the bottom of the hull. Monitor it frequently for condition and adequate protection.

THRU-HULL FITTINGS: The Thru-Hull fittings are NOT grounded.

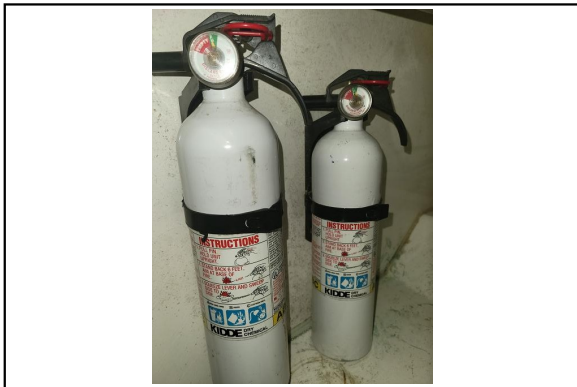
FIRE EXTINGUISHERS: Two (2) Type 5-B (2lbs) dry chemical with gauges. Appear serviceable. Location: cabin.
Both fire extinguishers read FULL.

Fire Extinguishers

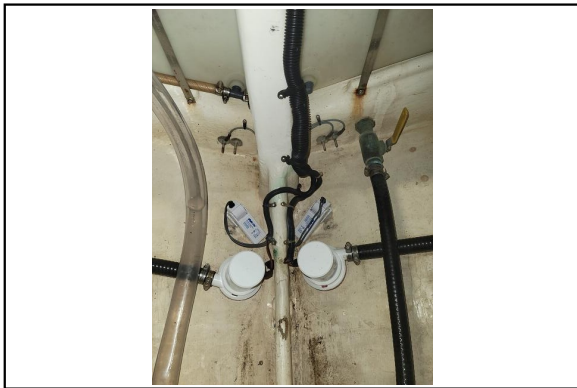
* **LIST: [B16]** Yes, one (1) midships Rule 90 GPH with remote float switch. And, two (2) AFT inside bilge compartment Rule 1500 GPH with remote float switches. Appears to be operable and serviceable. The bilge pump at midship has non marine electrical connections.

Bilge Pumps AFT

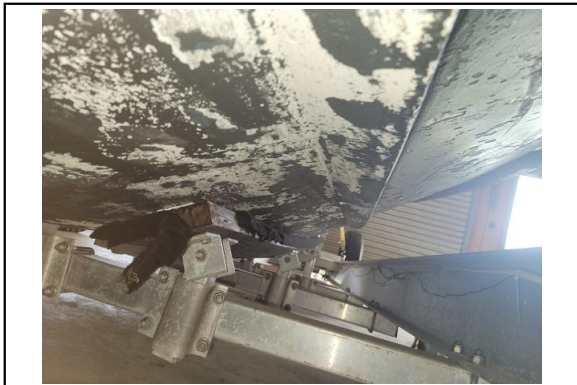
- * **CONDITION OF BOTTOM PAINT: [B20]** The bottom paint needs to be removed.
Poor condition, (see photos)

Bottom Paint

B.19 (PAGE 30) <User Define> The drain plug is frozen.	Investigate further and repair or renew as necessary.
B.20 (PAGE 30) CONDITION OF BOTTOM PAINT: The bottom paint needs to be removed condition is poor.	Further investigate and repair with like kind materials in keeping with accepted marine repair practices.
