JA OUTBOARD SERVICE, INC.
INDEPENDENT MARINE SURVEYING

Boston Whaler 370 Outrage

Report of Marine Survey

September 24, 2022

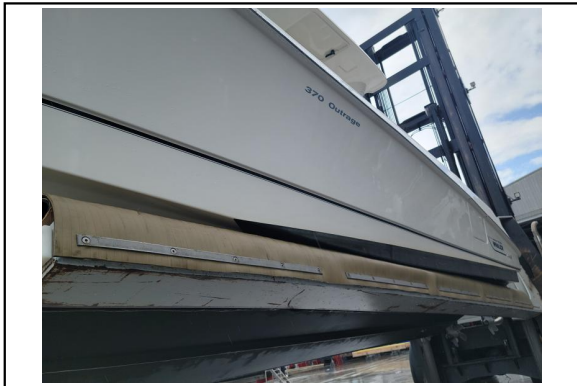
Port Hull Side

<User Define> One of the port side thru-hull fittings has a yellow stain running down.

* **NOTE: [B1]** A full detail is recommended to restore several areas of the hull and superstructure that have yellow staining. The majority of the yellow staining can be seen around the transom and near the water line (AFT).

A full detail is recommended to restore several areas of the hull and superstructure that have yellow staining.

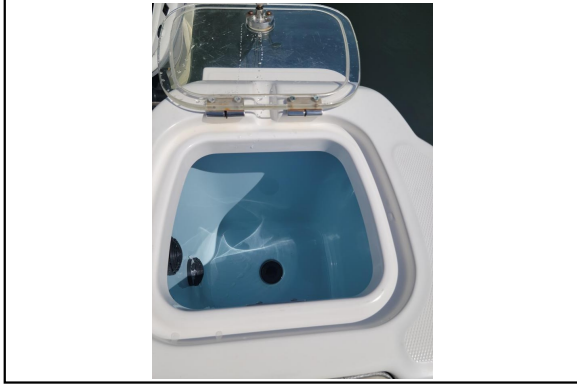
Baitwell

LIVE BAIT WELLS: A live-well is located in the AFT of the deck. It is fully insulated to keep storage cool and drains out-side the boat.

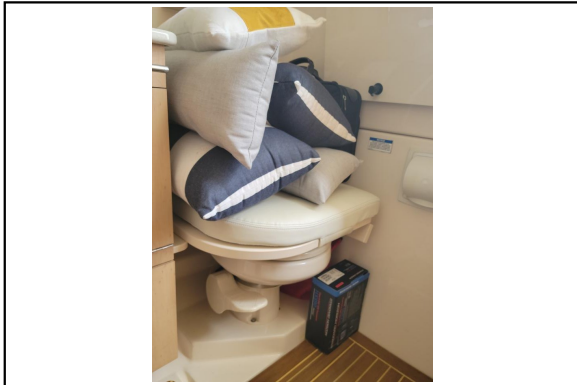
Toilet

HEADS: One (1) toilet with a 20 gallon holding tank. Flushing pump and macerator work well.

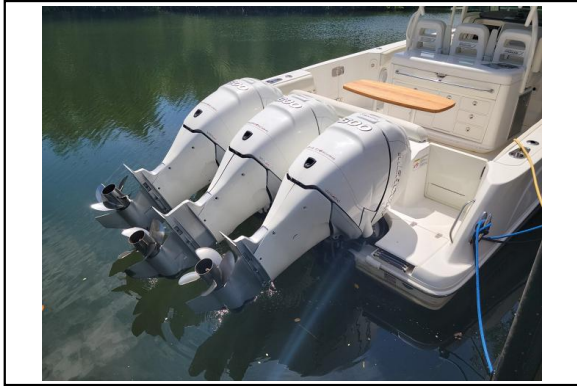
Engine AFT view

TYPE/MANUFACTURER/LOCATION: Triple (3) In-line 6 cylinder four stroke, Mercury Outboard.

NUMBER OF CYLINDERS/HORSE POWER: Mercury Verado 300 HP, 2013.

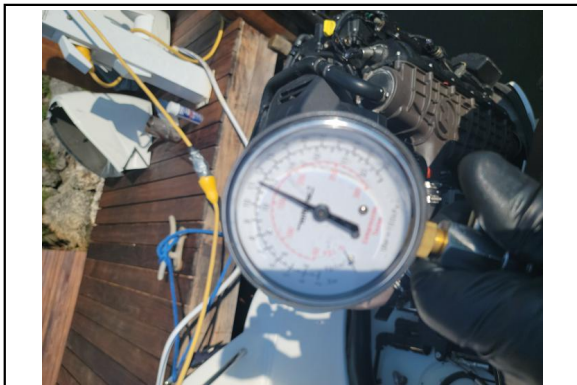
CNTR ENG Comp Test.

The Port engine Average Compression is 170 psi and the differences between cylinders is 1 psi. The STBD engine Average Compression is 170 psi and the Cylinder Compression difference between cylinders is 1 psi. And, the CNTR engine Average Compression is 170 psi and the difference between cylinders is 2 psi. **Excellent Compression**

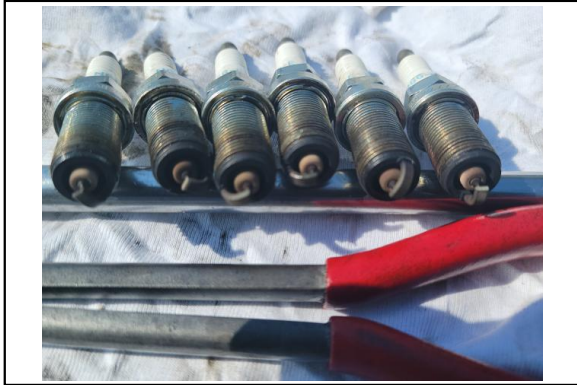
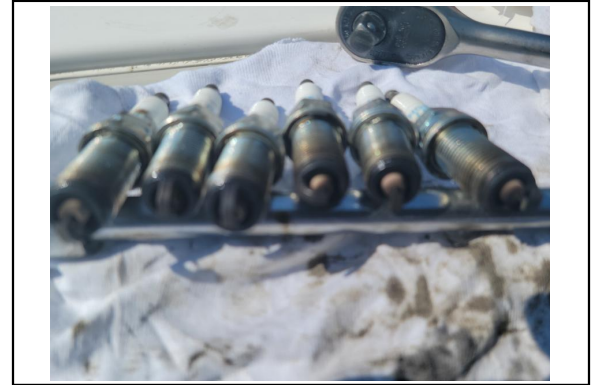
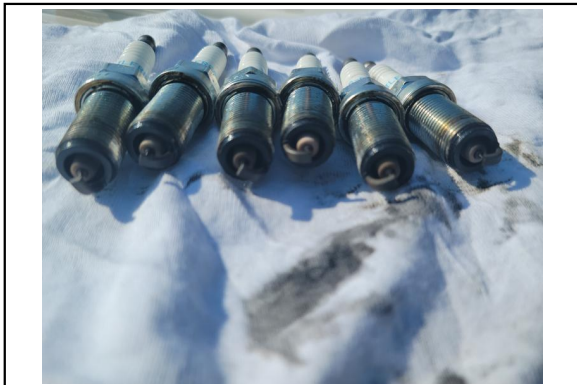
All spark plugs reflect a consistent combustion.

A consistent combustion throughout all the spark plugs reflex a tuned engine.

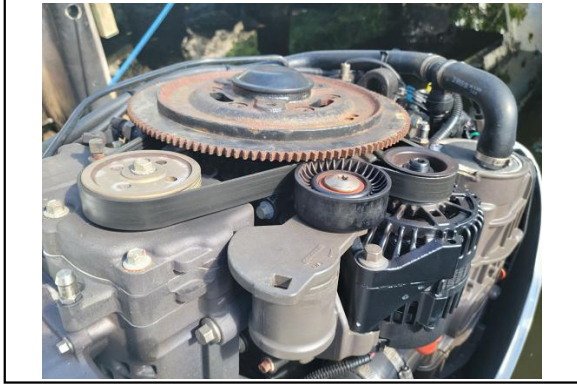
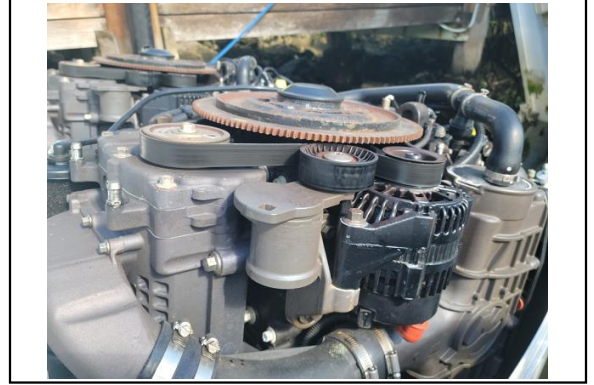
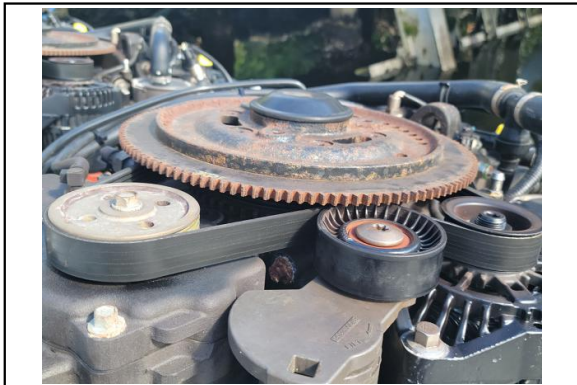
* **NOTE:** [B5, B6] No nicks or scratches on all three engine covers.

Note: The seal on one of the engines covers is damaged / worn.

The seal on one of the engines covers is damaged / worn.

Investigate further and repair or renew as necessary.

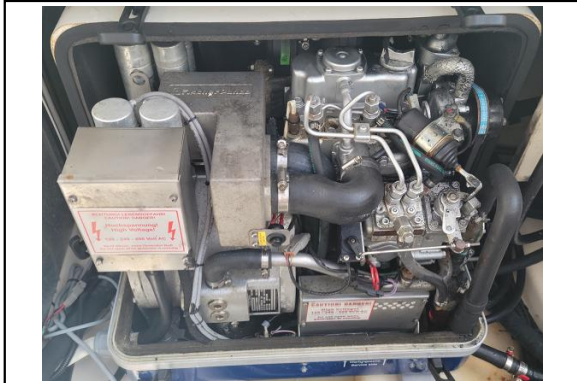
Generator

LOCATION: AFT compartment. Well insulated and sound protected.

* **FLUID LEVELS:** [B7] The fuel level is not being read at the Panda display. Due to the sender being defective.

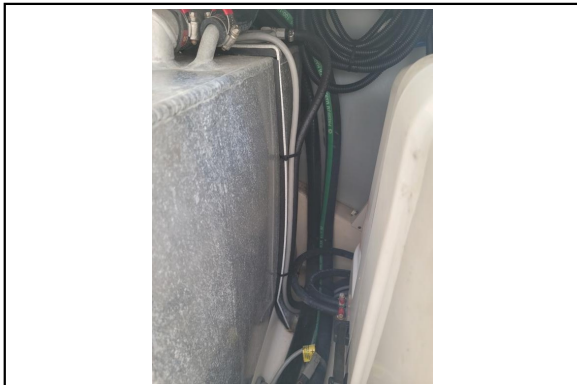
Fuel Tank-Generator

NOTE: 20 gallon aluminum fuel tank.

ABYC H 33.10.6, Fuel Tanks shall be installed and restrained so that the fuel tank does not move at the mounting surface more than 1/4 inch (6.4 mm).

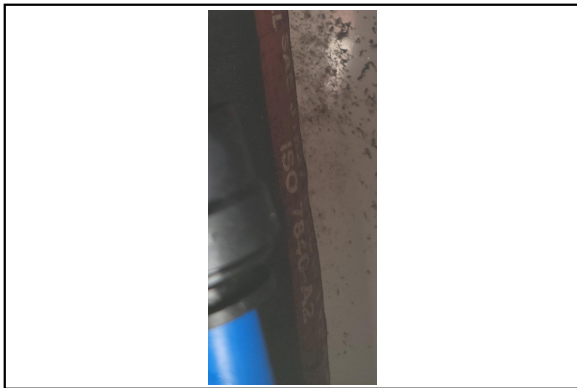
FUEL LINES: Fill hose was sighted to be doubled clamped and Grade USCG type A2.

Gas Fill Hose -A2

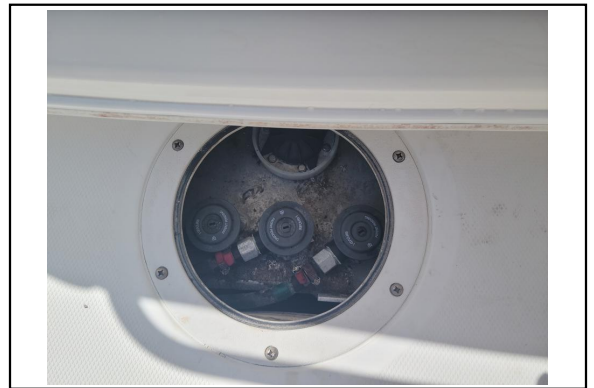
Gas Tank Eng. Fill Hoses

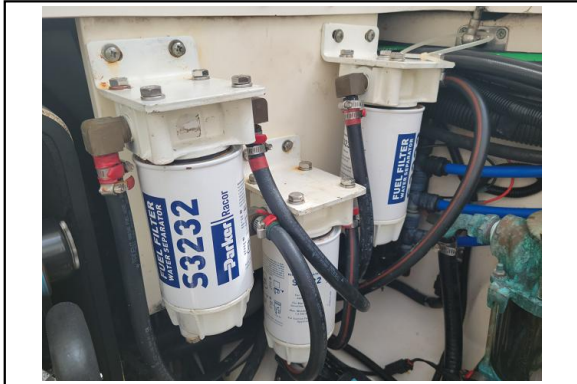
WTR Separator Filters

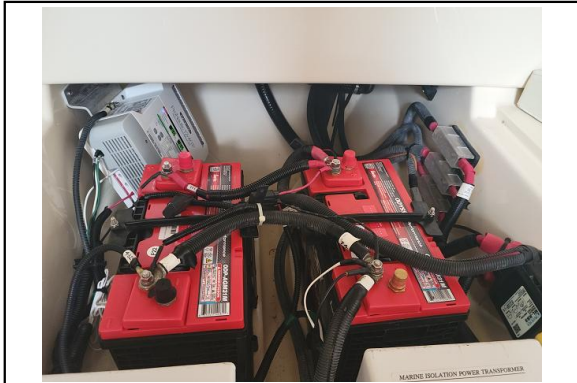
VOLTAGE/BATTERIES: House Batteries: Odys Performance-AGM 31M. Note: Purchased on 8/18/2022.

House Batteries

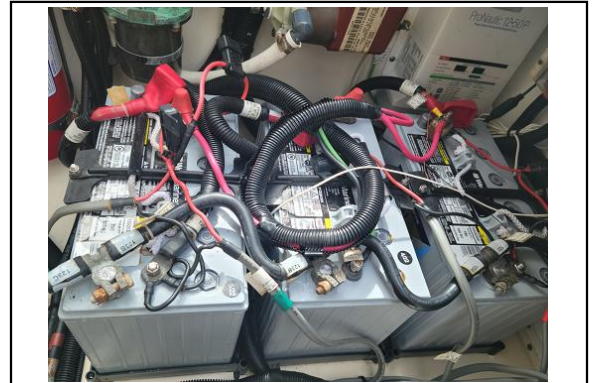
Engine Batteries: Brute Force AGM 31M. Purchased on 9/27/2021.

Batteries-Engines

INSTALLATION/PROTECTION: Three (3) AGM batteries for the engines are located in the AFT compartment. Two (2) house batteries (AGM) are location in the galley compartment.

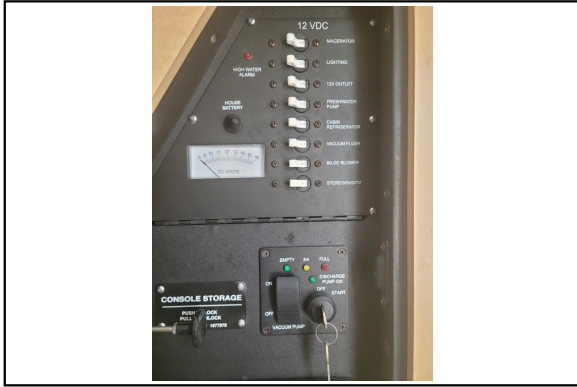
DC Panel

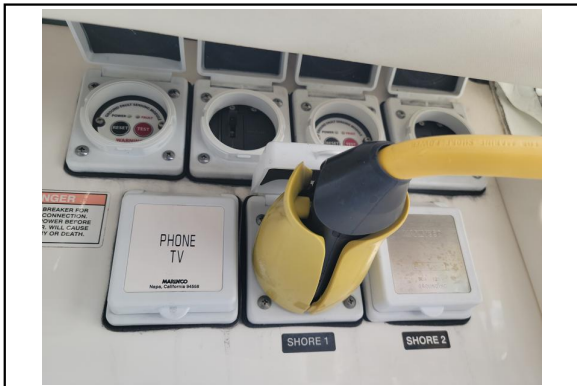
SHORE POWER INLET/CORD: Number: Set of two (2) Marinco 30 amp. Location Midship STBD underneath gunwale. Weather protected: Yes.

Shore-Power Connection

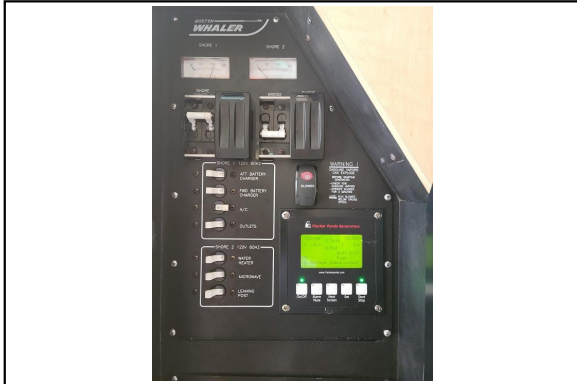
AC Control Panel

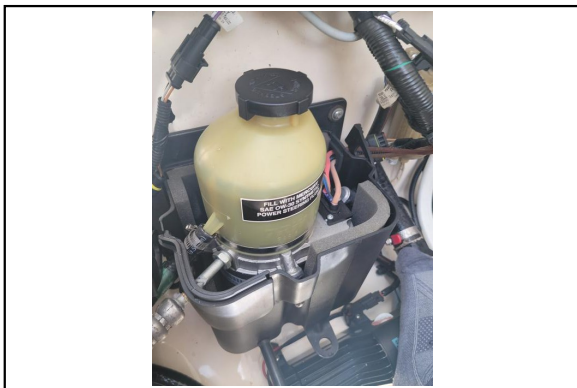
PRESSURE/RESERVOIR TANK: Mercury Verado Power Steering. Equipped with Three (3) oil pumps / reservoir units and one cylinder per engine.

Power Steering Reservoir

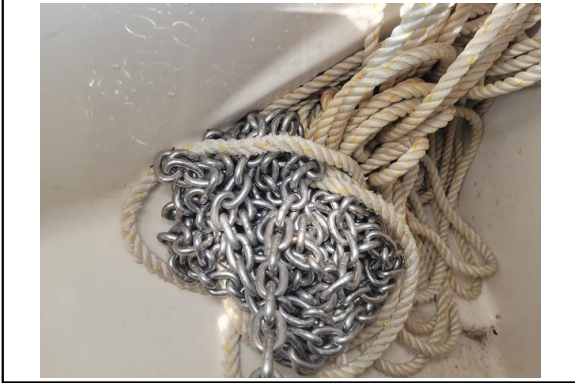
LINE/RODE MATERIAL: Forty feet of S.S. chain connected to 100 feet of 3 strand HS 9/16" rope.

S.S Chain- Anchor

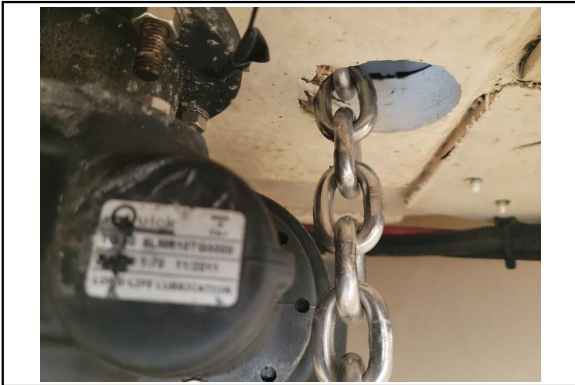
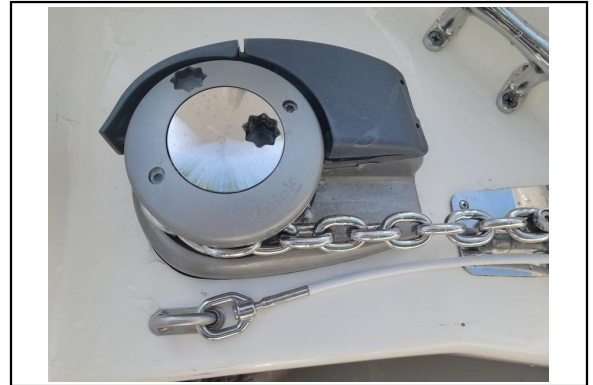
WINDLASS: Quick Windlass, Appears serviceable. Switch is accessible at bow and cockpit companionway. Mounting appears adequate for service required.

Winch-Motor

Winch

CONDITION AND DEFICIENCIES: Tested windlass from helm and bow control -works well.

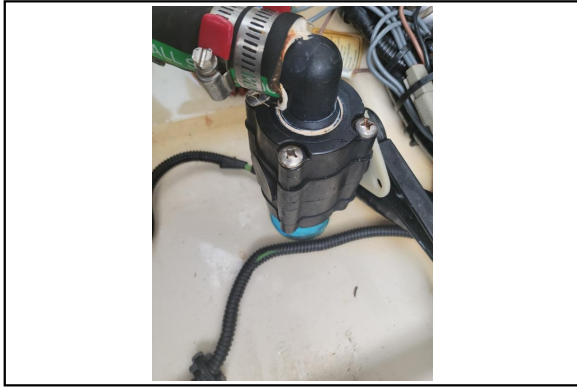
thru-Hull for Macerator

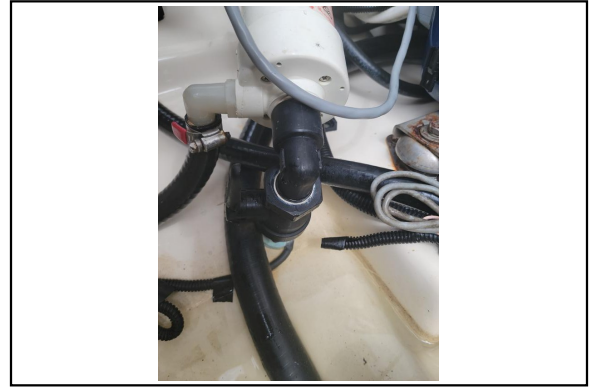
Thru-Hull for Baitwell

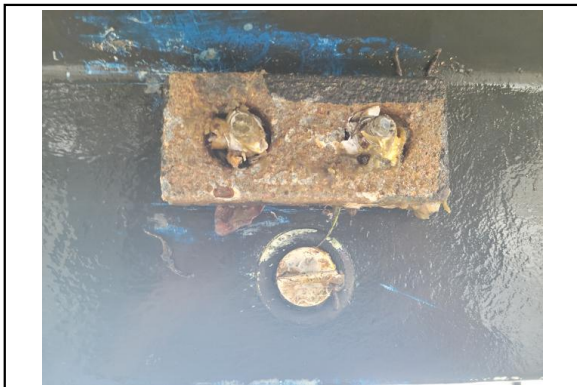
DRAIN PLUGS: Drain Plug is of brass and is sealed.

Drain Plug - Anode

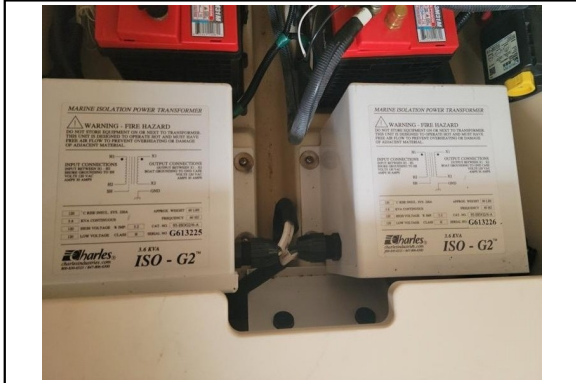
CHECK FOR GALVANIC ISOLATOR: Yes, two (2) made by Charles Industries model ISO-G2

Battery Isolator

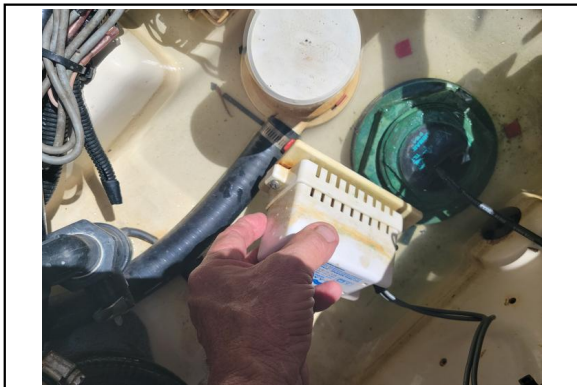
* **LIST:** [A2] Yes, two (1) midships and two (2) AFT inside the bilge compartment. Rule 2000 GPH with remote float switches appears to be operable and serviceable.

Auto-Switch-NOT SECURED

NOTE: Note: The manual operating switches in the main DC panel are well marked and are operable. The center bilge pump float switch is not accessible for the surveyors visual observation (tested). The motor was listen to be operable.

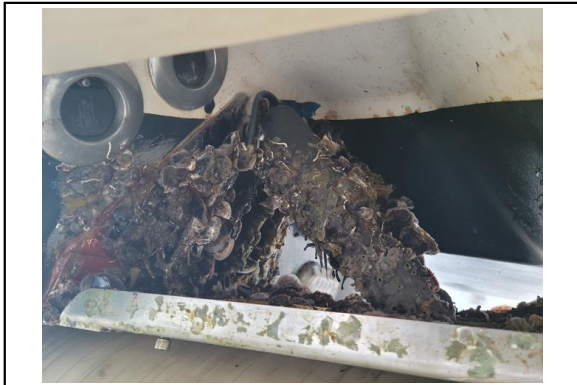
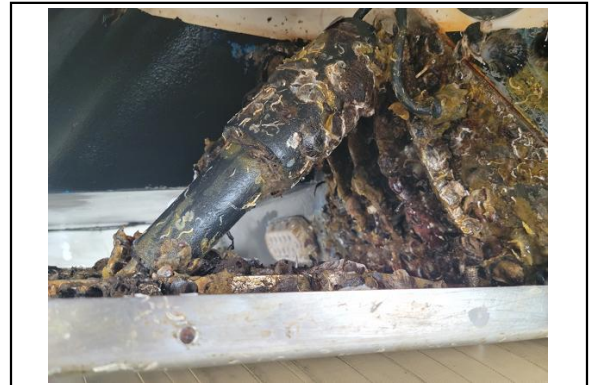
Both Trim Cylinders on each Tab are covered with sea-critters. In-order to diagnose they need to be pressure washed.

Port Trim Tab

STBD Trim Tab

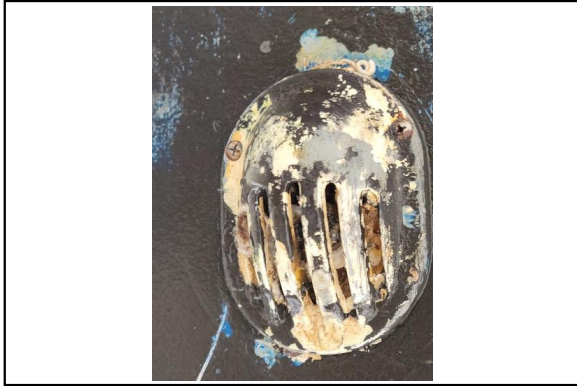
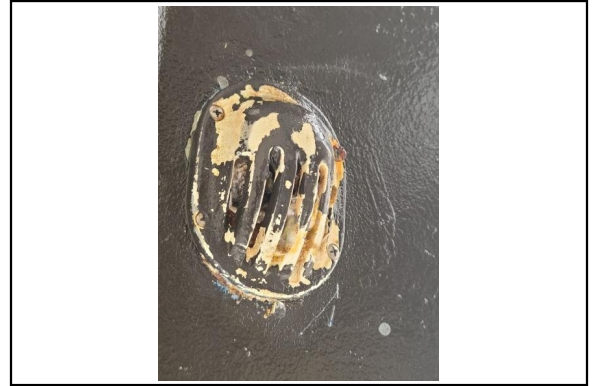
* **STRAINERS/SCOOPS/SCREENS:** [B13] Two (2) Scoopers for the Thru-Hull gate valves are external bronze alloy slotted type.

Scupper

Scupper pic 2

B.13 (PAGE 32) STRAINERS/SCOOPS/SCREENS: Both scoopers are restricted with sea critters.	<i>Pressure wash both thru-hull gate valves to unclog passage.</i>
B.14 (PAGE 32) CONDITION OF BOTTOM PAINT: Bottom paint not prepared and applied correctly.	<i>Further investigate and repair with like kind materials in keeping with accepted marine repair practices.</i>
