JA OUTBOARD SERVICE, INC.
MARINE SURVEYOR ASSOCIATE

Center Console
Scout 275 lxf

Report of Marine Survey

February 16, 2024

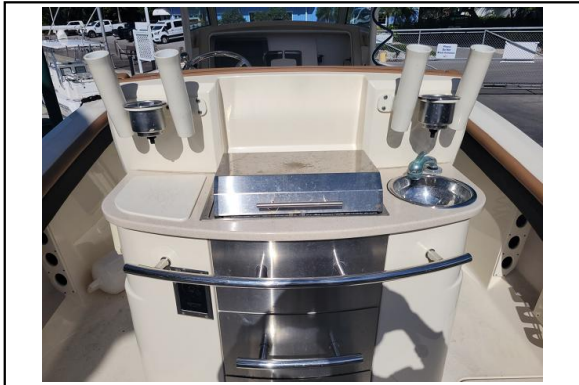
Grill, Sink at CC Stern Side

* **SINKS:** [B2] Did not Power-Up.

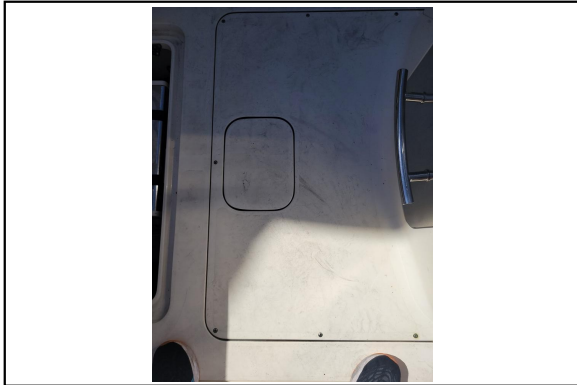
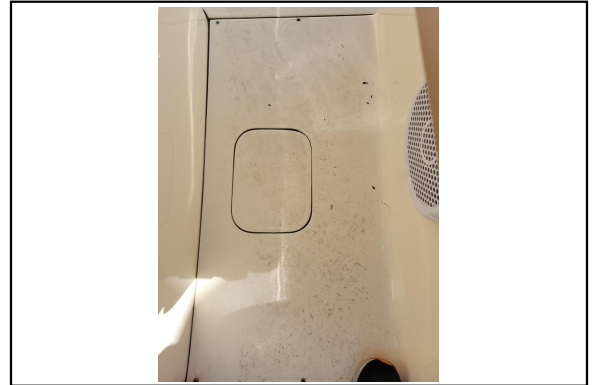
SECURED: Tank is foamed-in and secured to the transom.

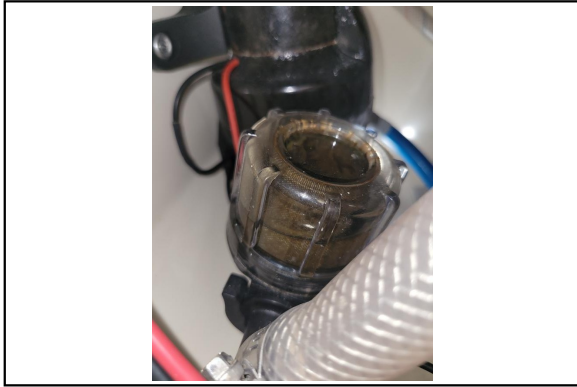
FILTERS: Dirty

Fresh Water Filter, DIRTY

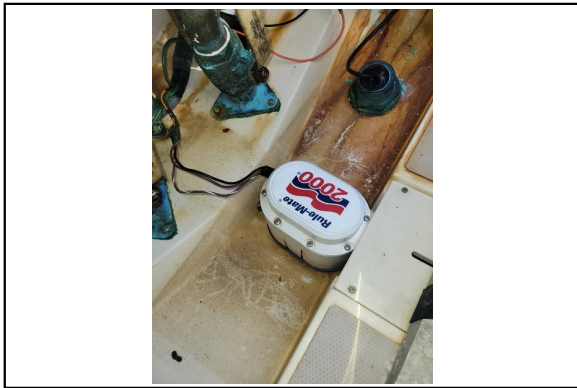
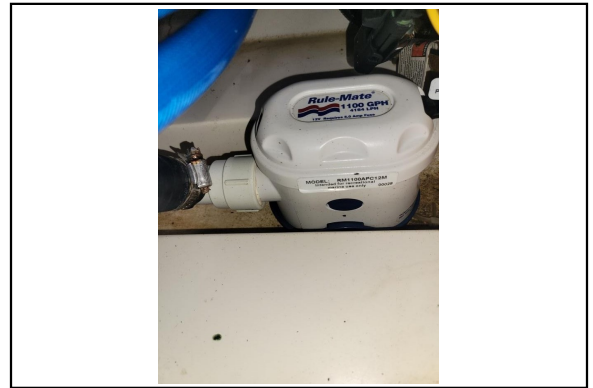
LIST: One (1) Rule 2000 w/ Automatic Switch in the bilge compartment and one (1) Rule 1100 GPH Auto-Switch mid-ship.
Both Powered-UP.

Bilge Pump AFT

Bilge Pump FWDjpg
