Report of Marine Survey

Prokat

2660 Catamaran CC, 2007

April 20, 2021

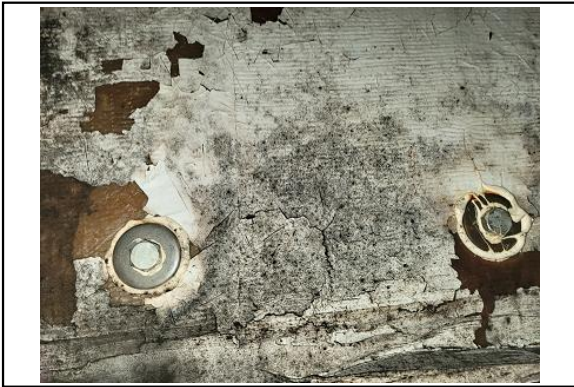
Engine Bolts

*B.1

Spider Web Cracks at port transom corner.

FINDINGS	RECOMMENDATIONS
Spider Web Cracks at port transom corner.	Further investigate and repair with like kind materials in keeping with accepted marine repair practices.

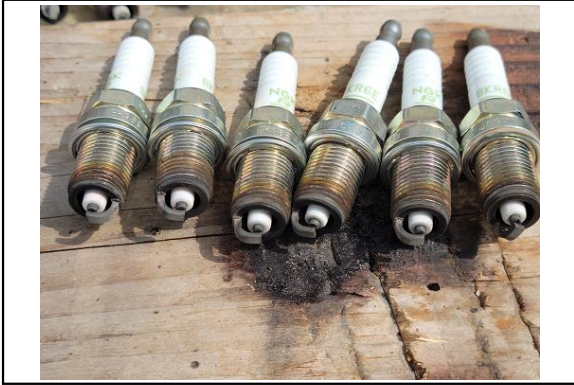
Port Spark Plugs

A consistent combustion throughout all the spark plugs reflex a tuned engine.

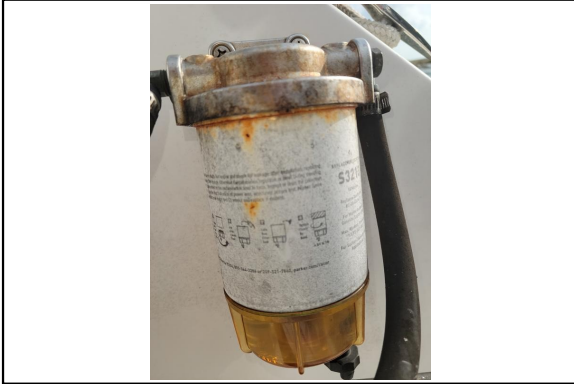
WTR Separators

***B.11**

Water Separator and in-line filters appear to need service.

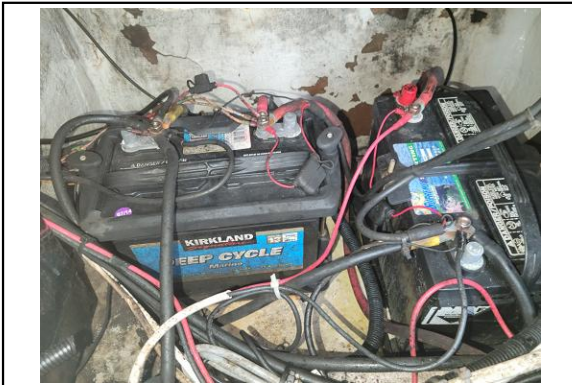
Port Bank

Two (2) batteries failed the conductance battery test and have a expired date.

*B.13

The positive battery studs were not protected from accidental contact.

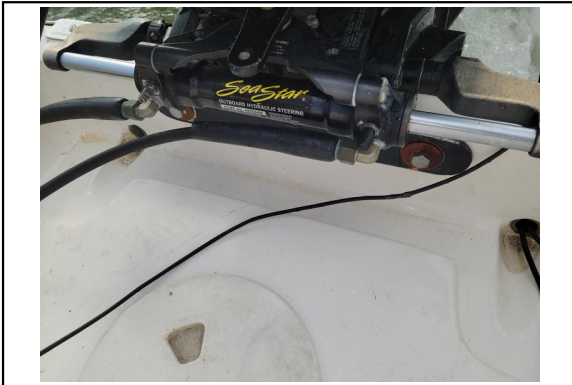
STBD Cylinder

Hydraulic, by Sea Star, where sighted appeared serviceable. The stainless steel shaft appear polished. No leaks and corrosion to a minimum.

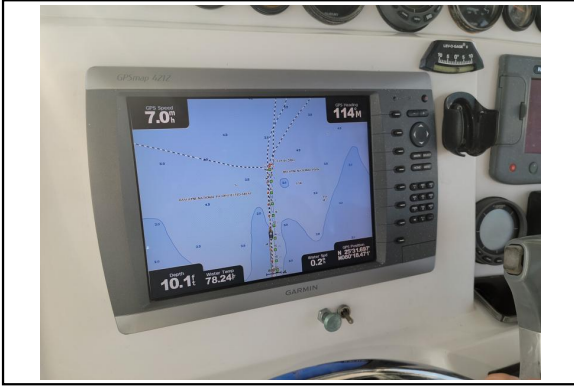
GPS Map 4212-Garmin

Garmin- GPS map 4212. GPA, Depth and Radar powered up. Screen is clear.

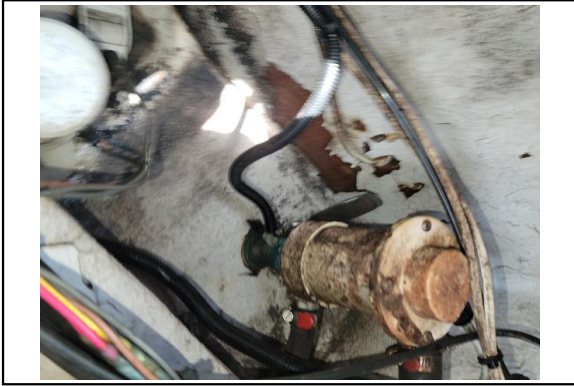
Thru-hull valve

AFT on STBD side, accessible.

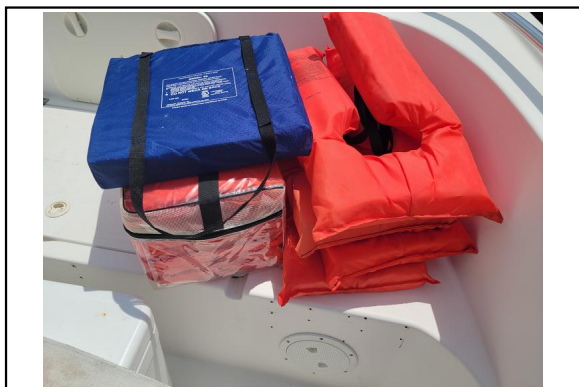
Life Jackets

One (1) Type IV-U.S.C.G. approved throwable device.

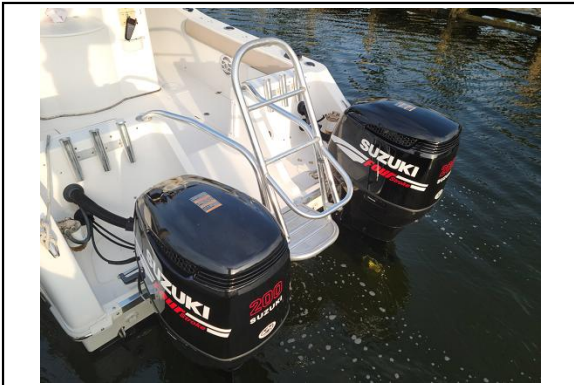
Suzuki DF 200, 2006

- * There were no oil or coolant leaks observed. On both engines or in the exhaust water.

- * The water temperature is in Fahrenheit (133-135 degree) both engines. Battery voltage charge from the alternator did not exceed 16 V. These figures are comprised of data readings from the vessel gauges while underway on the above stated date and time of the sea trial.

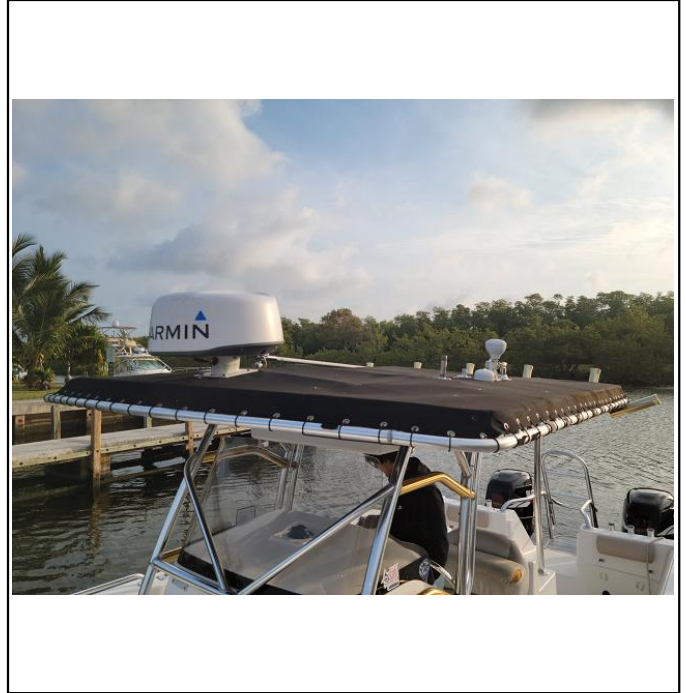
FINDINGS	RECOMMENDATIONS
The T-Top canvas is worn it does not hold water. The canvas is torn were the marine antenna lays over.	Repair or Replace with marine grade material and practice.
