JA OUTBOARD SERVICE, INC.
MARINE SURVEYOR ASSOCIATE

Center Console
Scout 275 lxf

Report of Marine Survey

February 16, 2024

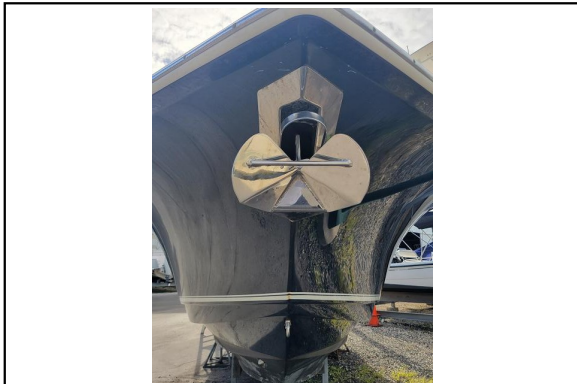
Stem View

STEM: Sharply raked stem of reinforced fiberglass.

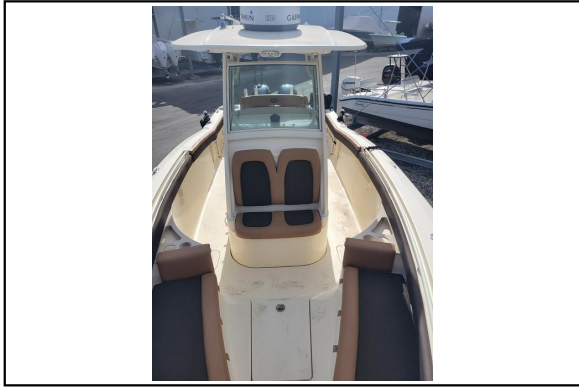
Bow Cockpit View

<User Define> Floor is solid. No soft spots.
Self-Bailing Cockpit.

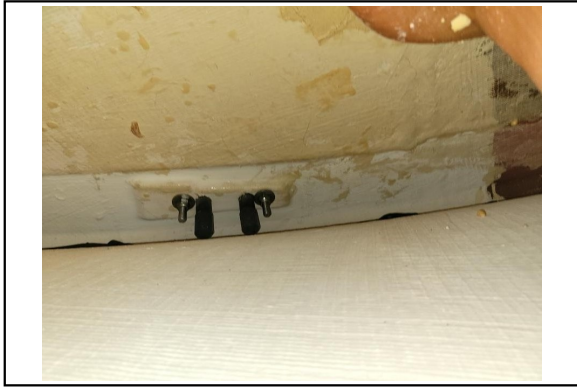
Deck to Hull Joint

FASTENERS: Not visible fiberglass reinforced. .

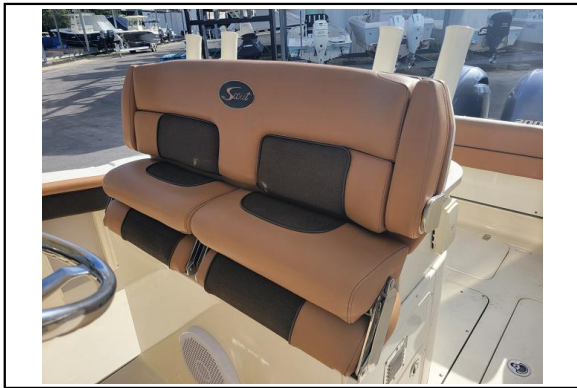
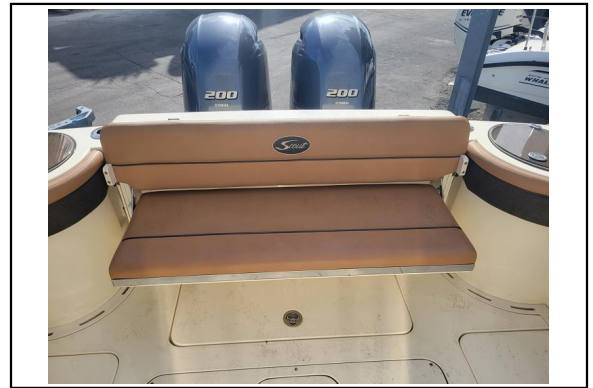
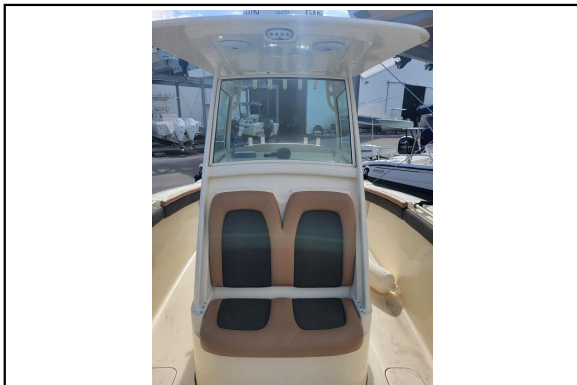
SEATS: Dual seat and leaning post with cushions and arm rest.
All Upholstery is in good condition.

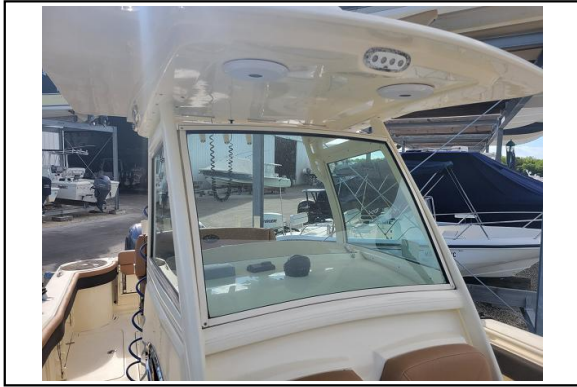
Windsheid

WINDSHIELD: Tempered Glass Enclosure
NO Stress Marks

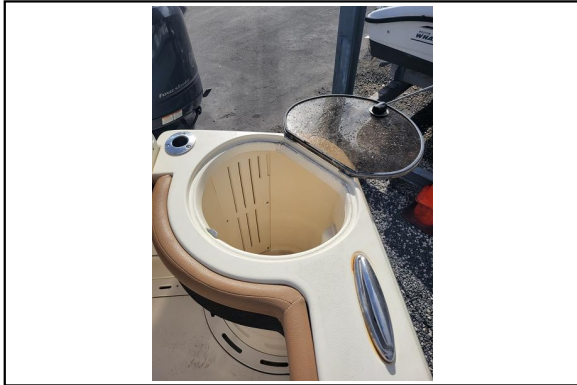
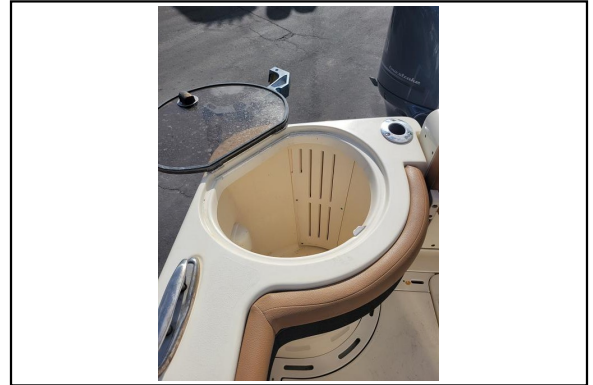
LIVE BAIT WELLS: Two (2) 20 gallon livewell located at the AFT of the boat.
Both pumps Powered-Up.

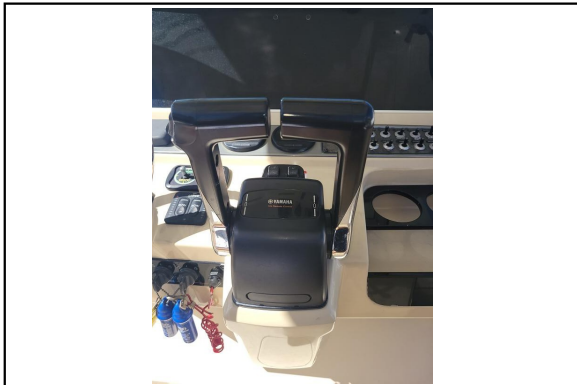
Control

THROTTLE CONTROLS: Yamaha Remote Dual Control-Gable Wire.
Engines were shifted into gear during idle-Both engaged well.

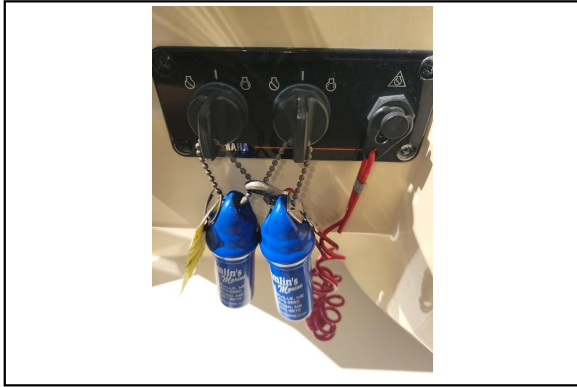
Emergency lanyard

EMERGENCY SHUT DOWN: Engine shut down pull cable (lanyard) clearly marked beneath key switch.

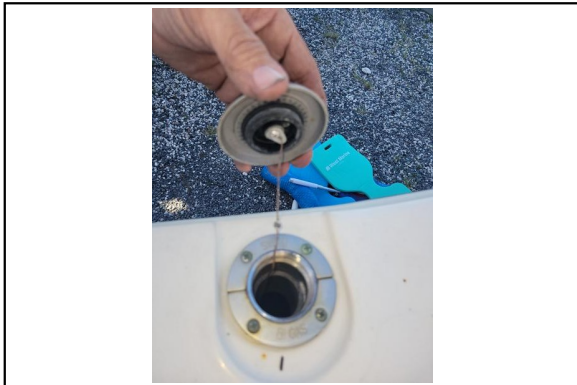
Gas Fill Cap Secured

Fill Cap Secured.

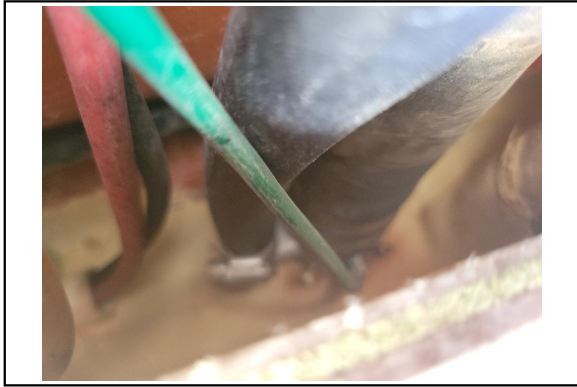
Gas Tank Fill GROUNDED pic 2

FILL PIPE GROUNDED: Yes, at fitting base.

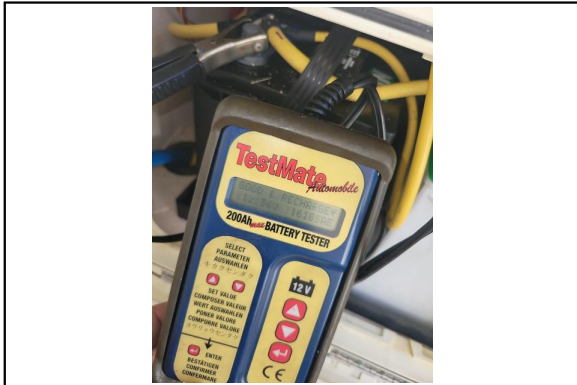
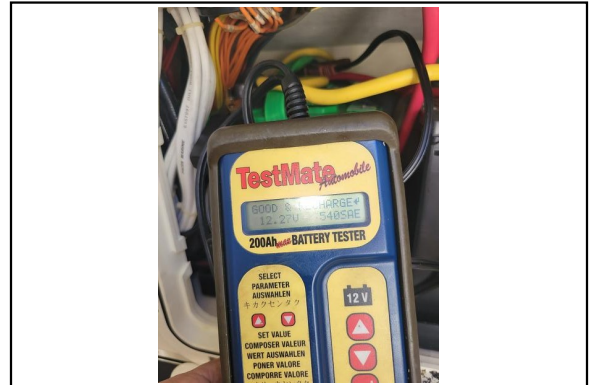
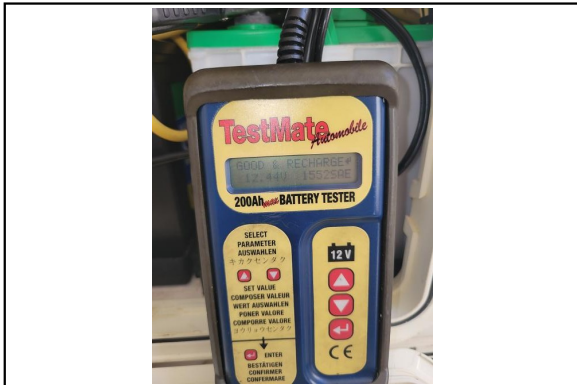
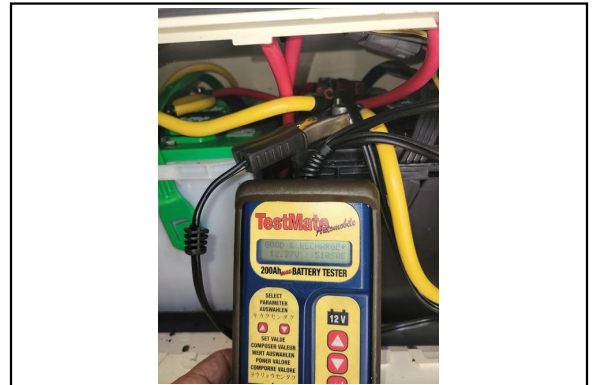
Note: All Tested with-in spec's.

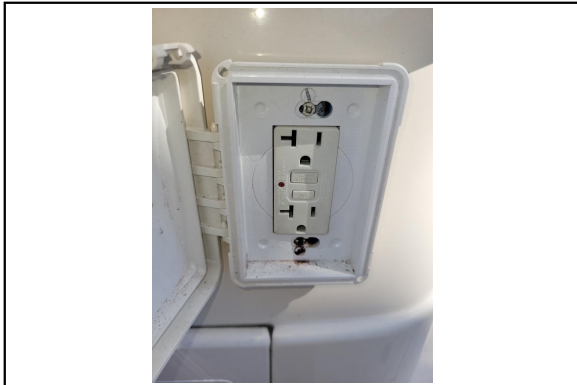
* OUTLETS: [C2] Two (2) Outlets GFCI.

Recepticle GFCI

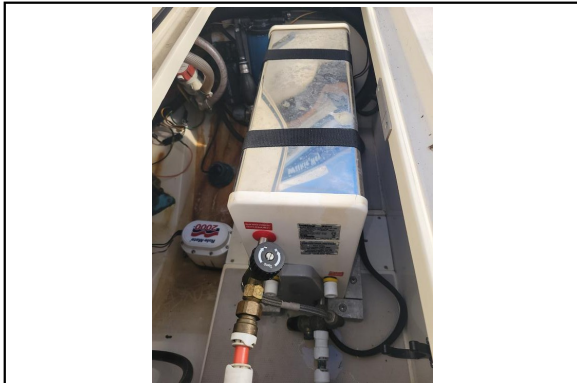
Water Heater

NOTE: Did not Power-Up. No Shore-Power Cord available.

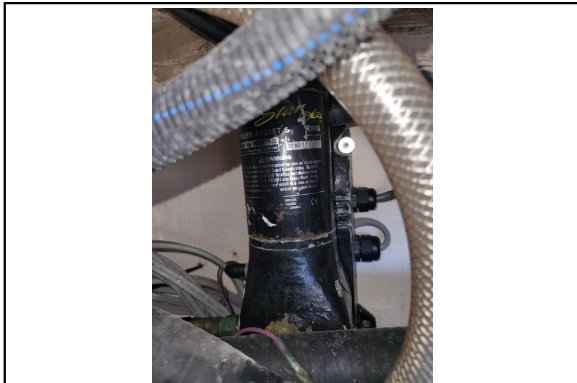
Steering Power Assit Unit

PRESSURE/RESERVOIR TANK READINGPower Assist Unit-Sea Star.

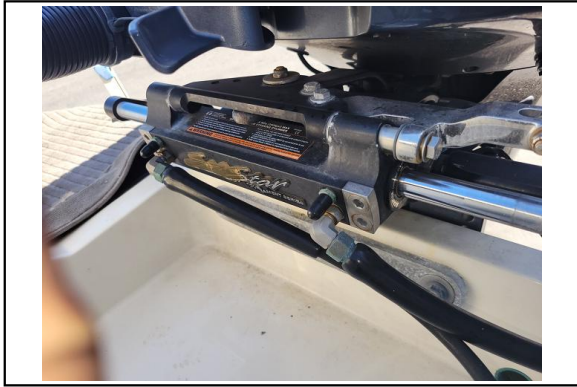
Steering Cylinder

Steering Cylinder Tie Rod

NOTE: Note:Steering was tested out of water, only (Not during a Sea-Trial). Responded well.

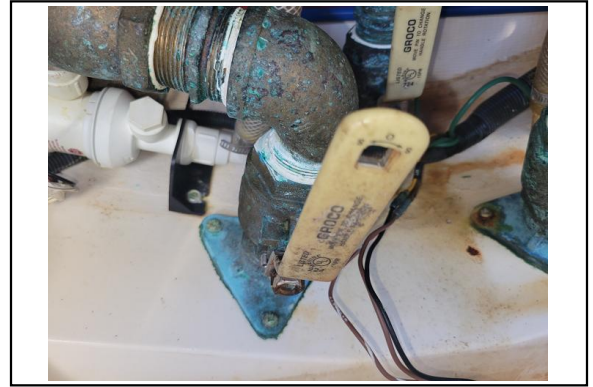
CONDITION: Two are Operable the ones for the Livewells.
The other three (3) are frozen.

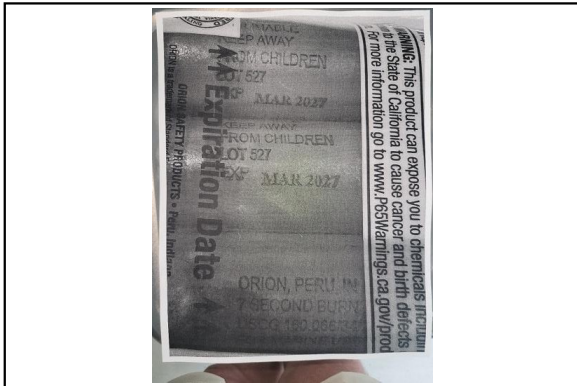
Flares

VISUAL DISTRESS SIGNALS: Flare Gun-Expiration Date for the Flares: March 2027.

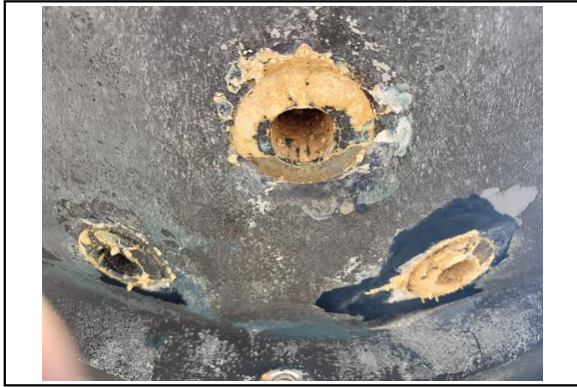
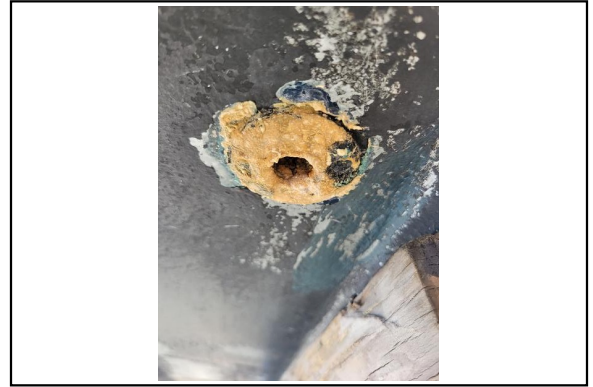
* **STRAINERS/SCOOPS/SCREENS:** [B9] Thru-Hull fittings.
Some corrosion on the thru-hull exterior fitting (bottom).

Scuppers for Livewells & Selfbailing ports

B.8 (PAGE 31) SEARCH LIGHT: Powered-Up, but remote is damaged.	<i>Investigate further and repair or renew as necessary.</i>
B.9 (PAGE 32) STRAINERS/SCOOPS/SCREENS: Some corrosion on the thru-hull exterior fitting (bottom).	<i>Recommend to pressure wash.</i>
B.10 (PAGE 33) ZINCS: One (1) anode on each trim tab. Need to be replaced.	<i>Replace Anodes.</i>
